## **REDACTED REPORT**

### **OF THE COURT OF INQUIRY INVESTIGATING THE ACCIDENT INVOLVING IROQUOIS NZ3806 NEAR PUKERUA BAY ON 25 APRIL 2010**

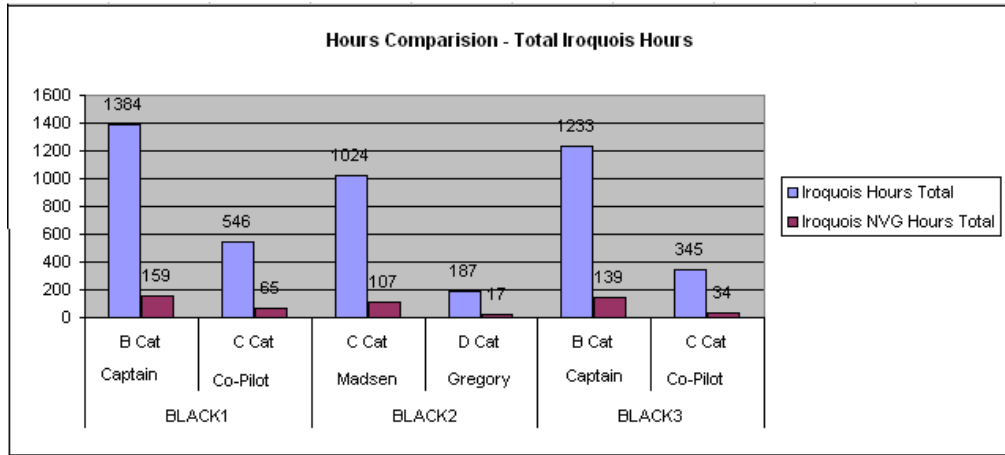
Figure 1. Hours comparison for crews of IROQUOIS BLACK.<sup>99</sup>

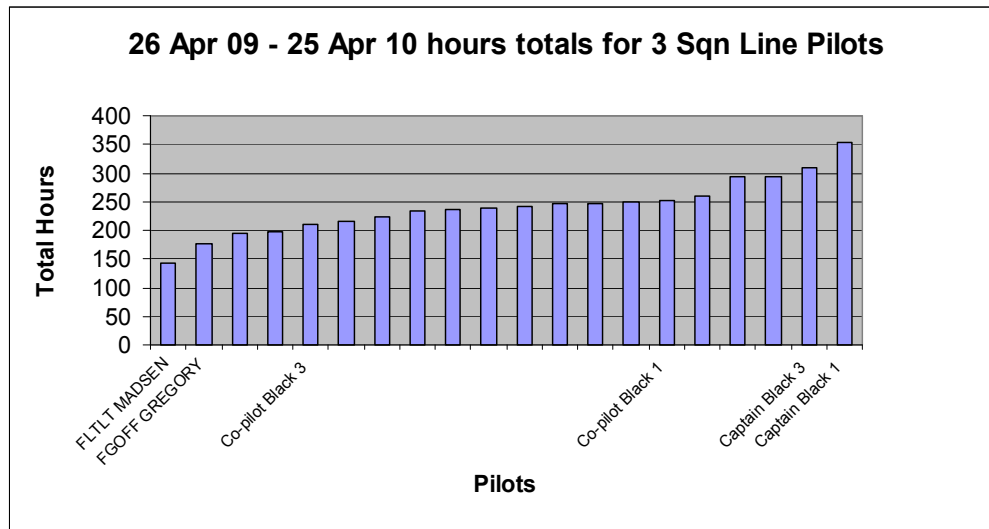
Figure 2. Pilot Hours 25 Apr 09 – 24 Apr 10.<sup>100</sup>

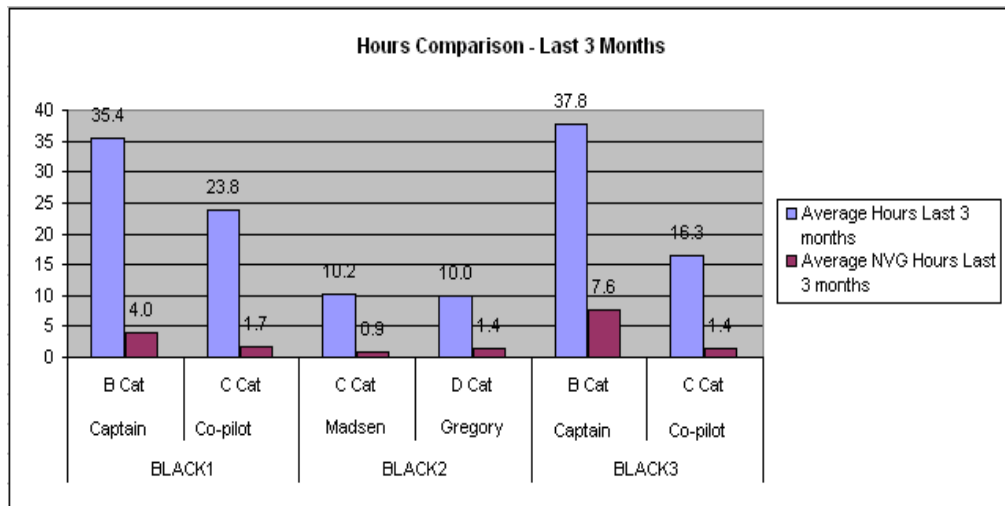
Figure 3. Pilot monthly average hours 24 Jan 10 – 24 Apr 10.<sup>101</sup>

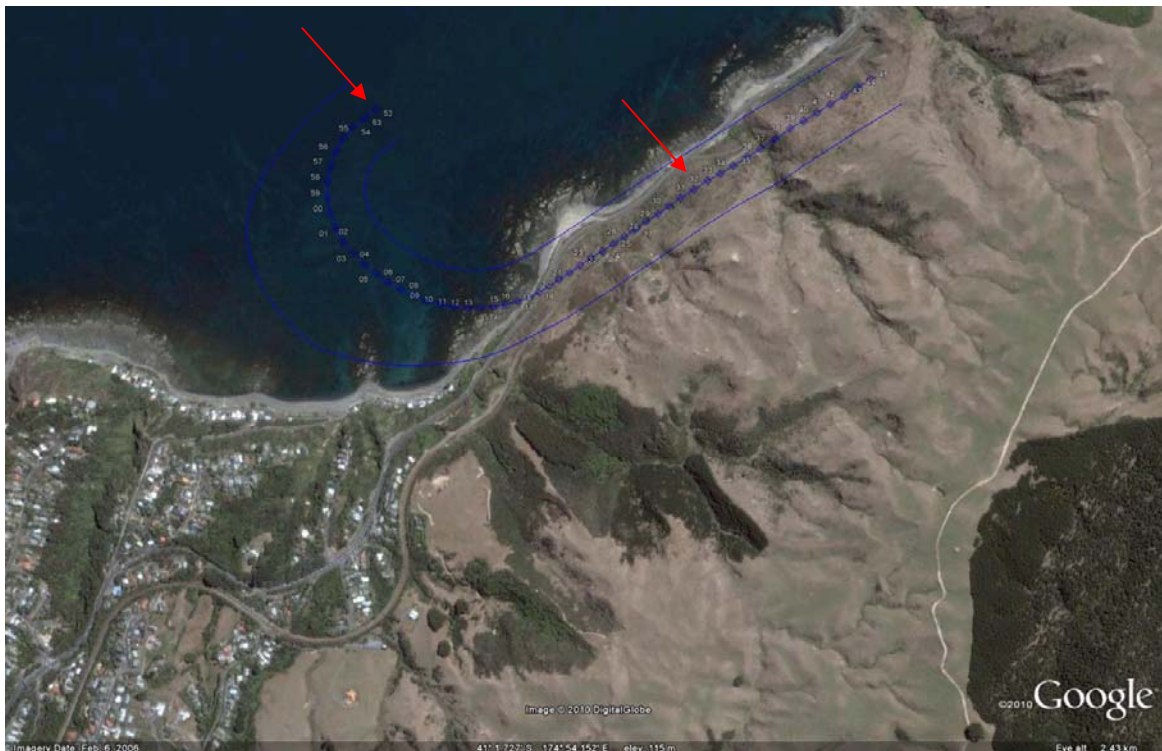
133. The points at which radar contact was lost and subsequently regained are indicated by arrows. The last recorded radar contact with BLACK 1 southbound was at 0548:52hrs. The next recorded radar contact, after entering IMC, was at 0549:31hrs, at which time BLACK 1 was at 1000ft AMSL tracking about 030°.

Figure 4. Probable Track of BLACK 1.  
Google Earth Image 26 Sep 10.

134. In continuing the turn, BLACK 1 reduced their closure rate with terrain, but did not achieve a safe heading. Had BLACK 1 not commenced a climb, the aircraft is likely to have impacted terrain between 15 and 60 seconds after entering IIMC.<sup>182</sup>

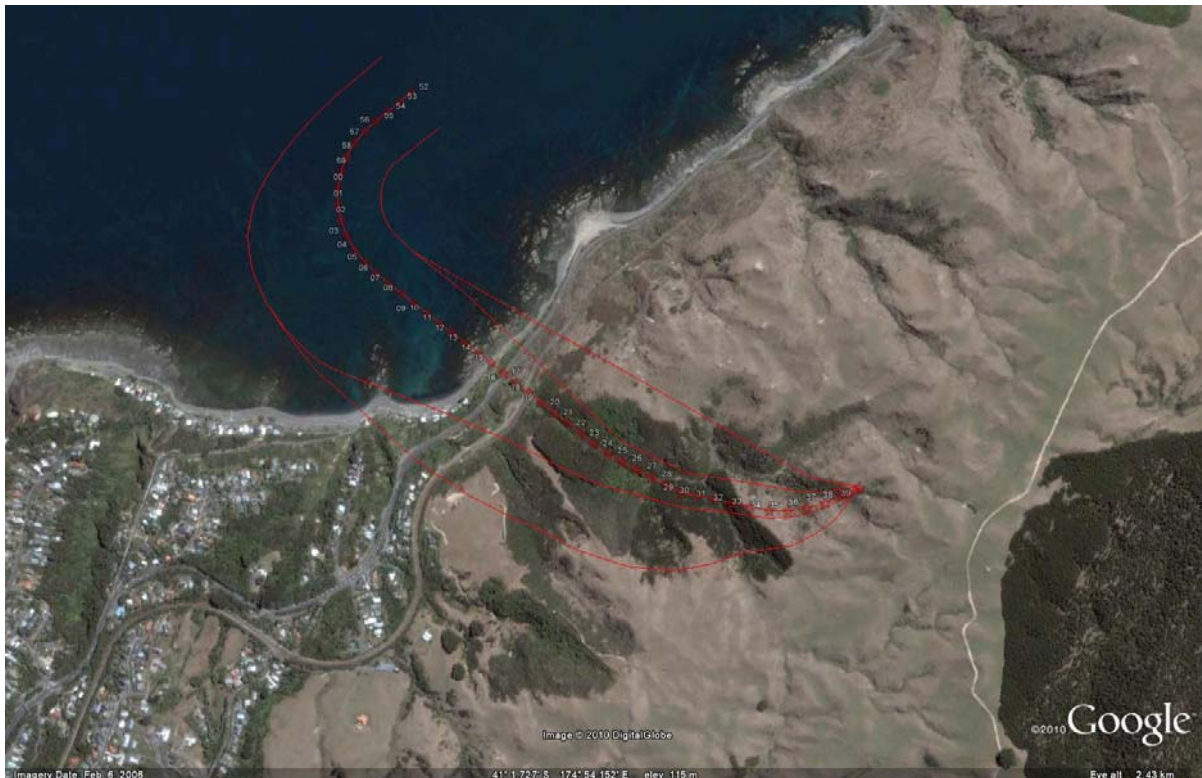
136. From the likely point of entering IIMC, BLACK 2's track is limited by the geography of the valley through which the aircraft must have flown to reach the accident site. The final portion of the track is considered to include a left hand turn to achieve a ground track of between 020° and 060°. These limits are drawn from evidence from the wreckage and the topography of the valley at that point.<sup>184</sup>

137. The estimated track, together with the limits of the track as calculated, is shown at Figure 5. The topography of the valley allows a greater variation in track at higher altitude, because the valley is wider. The inner limit lines represent the lowest possible altitude that the aircraft could have flown to reach the impact site. The outer lines bound the upper possible altitude track.<sup>185</sup>

Figure 5. Probable Track of BLACK 2.  
Google Earth Image 26 Sep 10.

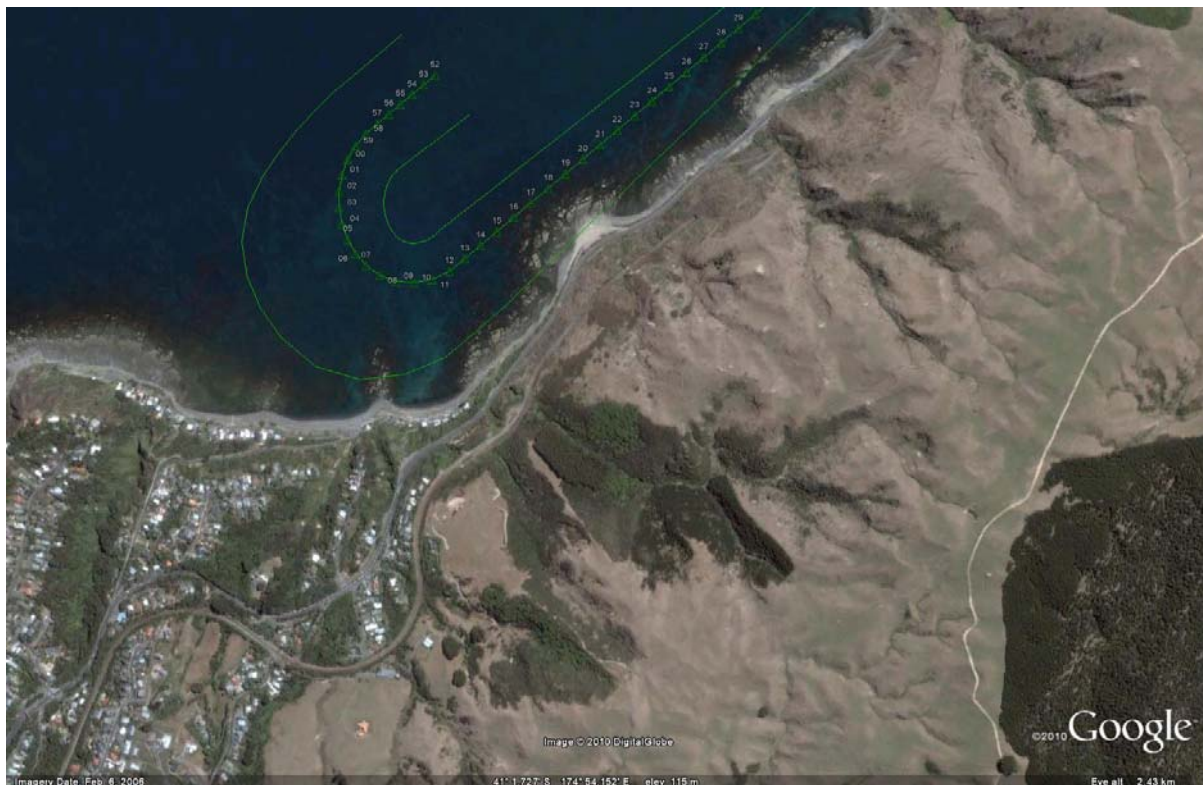
142. The estimated track of BLACK 3, together with the limits of the track, is at Figure 6.

Figure 6. Probable Track of BLACK 3.  
Google Earth Image 26 Sep 10.<sup>190</sup>

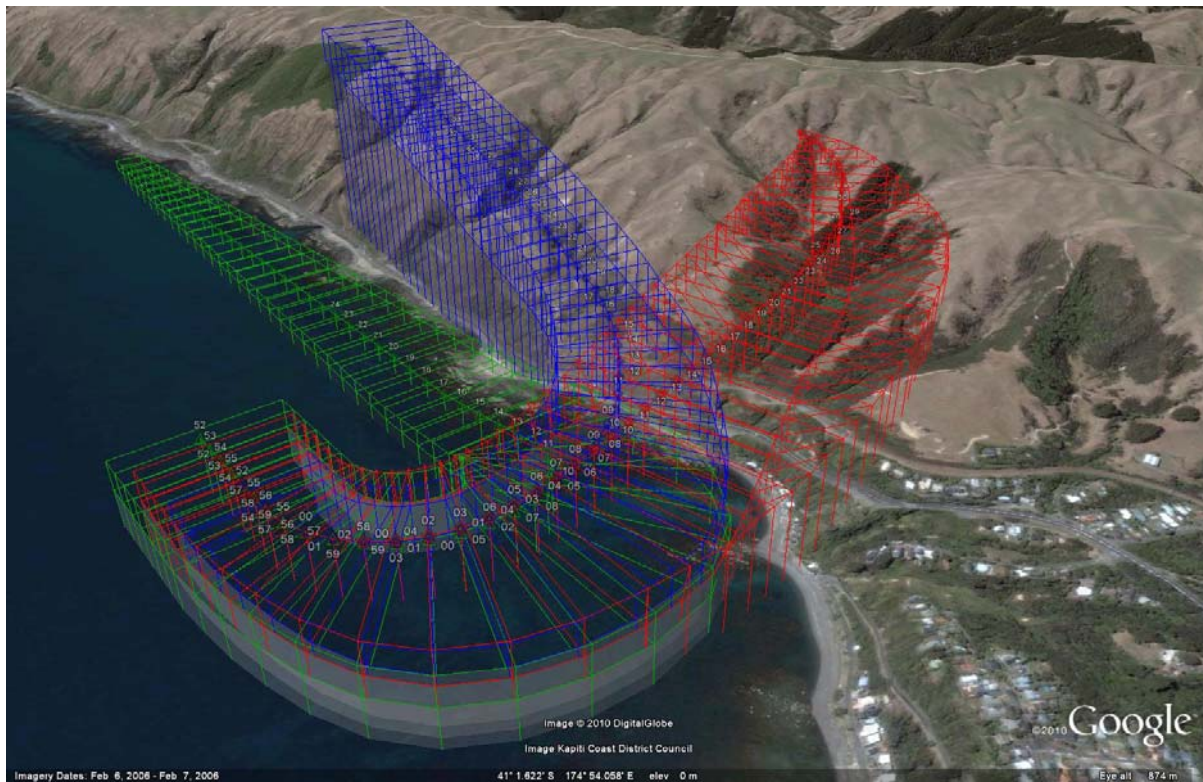
143. A three-dimensional view of the probable flight path of all three aircraft, viewed from the west, is shown at Figure 7.

Figure 7. Probable Flight Path of IROQUOIS BLACK Viewed from the West.  
Google Earth Image 28 Sep 10.<sup>191</sup>

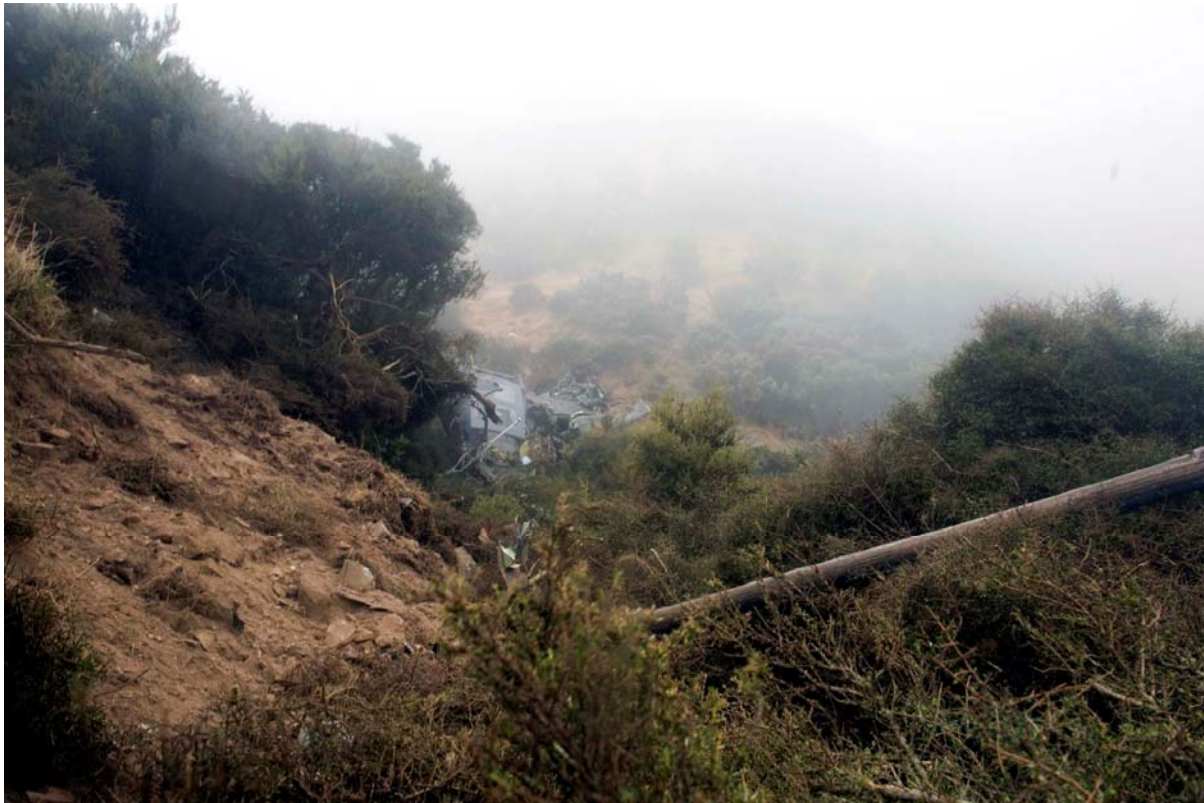
Figure 8. View from initial impact point toward wreckage.  
CPE Image OH 10-0284-442

145. At the initial impact point the forward edge of the RHS skid jammed in tree roots and the aircraft pivoted clockwise around this point prior to the skid detaching from the airframe. The initial impact caused the forward lower fuselage to peel away and has released the right hand pilot's seat from the fuselage structure.<sup>194</sup>

147. This second and final impact point caused the failure of the Left Hand Side (LHS) seating, the forward roof structure, the engine mounting points and the

remainder of the forward fuselage. The tail boom also detached at this point having been structurally damaged at the initial impact point.
