COURT OF INQUIRY
(Army 5202/2/301)

X1028259 PRIVATE MICHAEL VICTOR ROSS, RNZIR

DROWNED IN LAKE MOAWHANGO WHILE ON EXERCISE

WAIOURU MILITARY TRAINING AREA

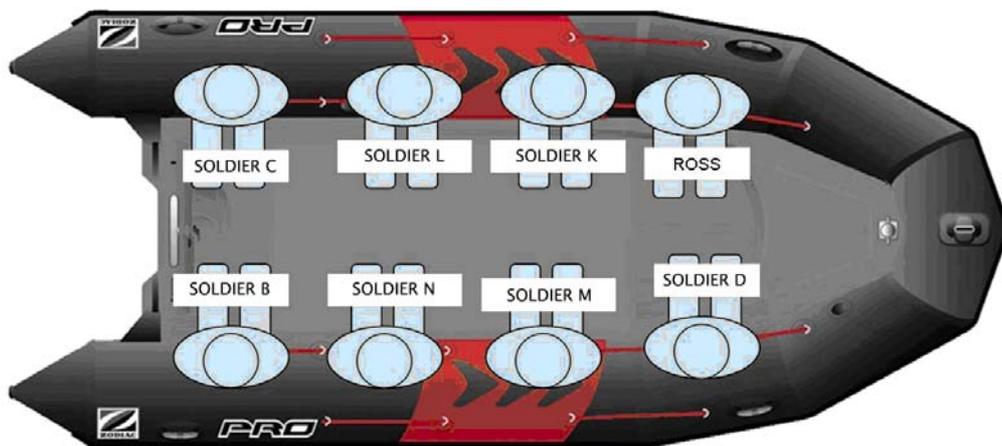
Figure 5: Original Positions on Zodiac 3¹⁶

18. At the time of the incident Zodiac 3 contained eight personnel – three of these persons were designated as Boat Crew (Boat Commander, Coxswain and Bowman) and five were passengers. Private Ross was the front left passenger aboard Zodiac 3 and was transiting from the Live Field Firing area on the eastern side of the Lake to the ramp on the western side of the Lake at the time of incident¹⁵ as shown in Figure 5.

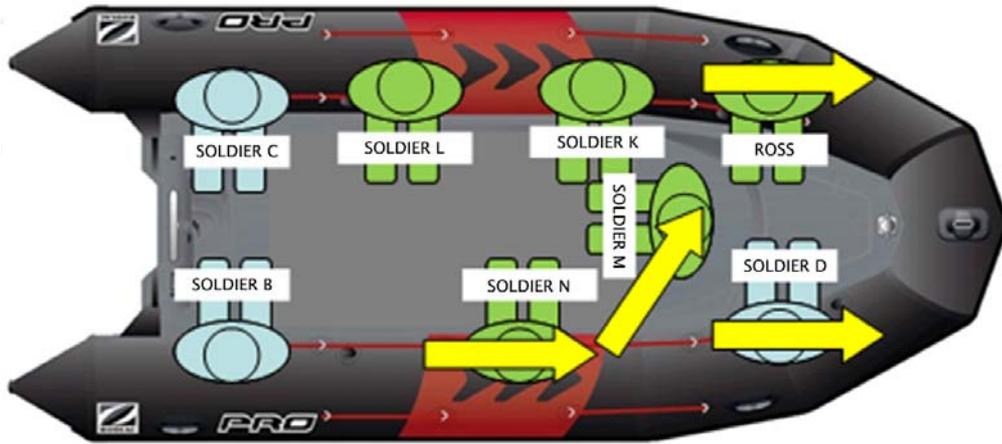
Figure 6: Repositioned locations on Zodiac 3²²

21. The Court finds that there were two causes for the bow of the Zodiac flexing excessively, which contributed to Private Ross falling overboard. These were:

22. When the bow was flexing excessively some passengers asked the coxswain to stop.²⁵ It appears that the boat slowed down rapidly and this sudden loss of speed may have unbalanced Private Ross. The deceleration may also have caused the Zodiac 3 pontoon that Private Ross was sitting on to regain its normal state thereby unseating Private Ross from Zodiac 3 into the water (*the bouncy castle effect*). It may also have caused Private Ross to lose his grip on the hand rails or, alternatively, Private Ross may have consciously let go of the hand rails in order to shift position on the pontoon.

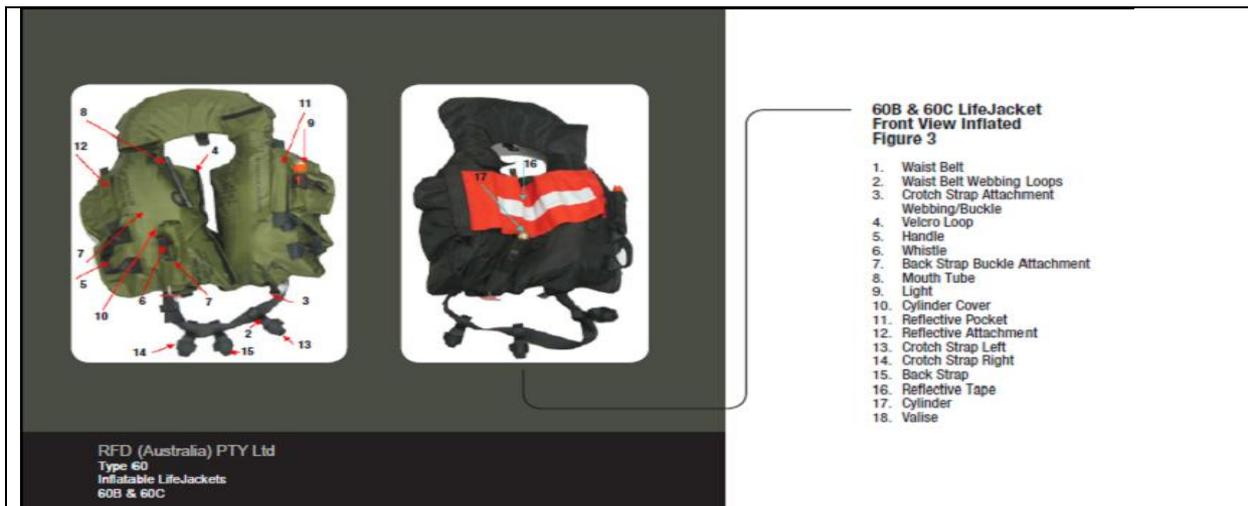
Figure 7. RFD Type 60B Life Jacket

39. At the time of loss, Private Ross was wearing the RNZN issued RFD Type 60B Life Jacket, also known as the Embarked Forces Life Jacket.⁶³ This Life Jacket was originally introduced into the RNZN as part of the Project Protector fit from Tenix Defence Pty Ltd to be held on board HMNZS CANTERBURY for issue to embarked New Zealand Army personnel. It can be worn with Army uniform, immersion suits and ordinary clothing.⁶⁴ NZ P96, *New Zealand Land Equipment Manual*, Part 2.4.2.7 paragraph 4(b)⁶⁵ provided detail about the life jacket that was in use by the EIC and worn by Private Ross on 25 September 2012.⁶⁶

41. Immediately after Private Ross was recovered, his life jacket (serial number 17780) was taken as evidence by the New Zealand Police and then subjected to technical testing by Survitec Group. The key result of the technical report was that Private Ross' life jacket did not have a serviceable gas canister attached to it:⁶⁸

...the CO₂ from the cylinder could only have entered the lifejacket bladder and could not have escaped through any leakage or fault. This suggests that the jacket was deployed at some time before this incident and was subsequently deflated, probably using the oral inflation tube cap which was then inadvertently left off. The jacket was then folded and reclosed without the cylinder being replaced and at this point would have appeared to have been in an operational condition.

56. It is recommended that the NZDF investigates the replacement of both the RFD Type 60B Life Jacket and the Mustang Life Jacket. Whilst the Court has found it highly likely that an inflated RFD Type 60B Life Jacket would have supported Private Ross, it is not known whether a heavier individual, weighing between 100 and 110kg with equipment, could be supported. Both life jackets also provide no protection from water spray. The Court also recommends that all life jackets should be centrally controlled, maintained and serviced within the NZDF and a NZDF standard for the

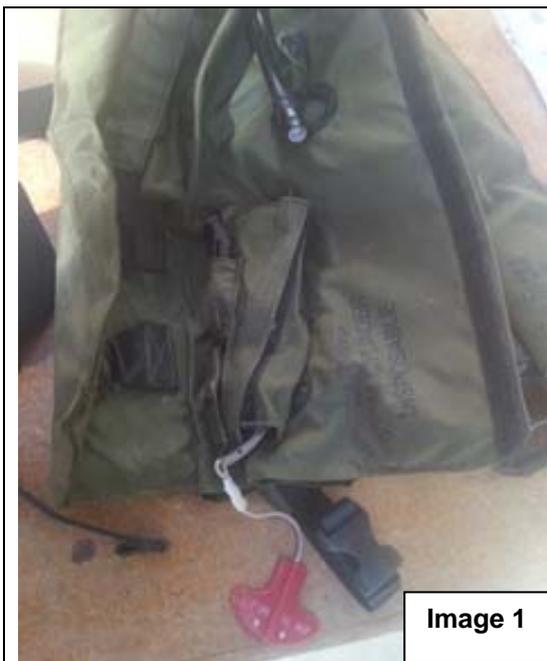
Image 1 shows the state in which the life jacket toggle was found – the metal firing lever is clearly exposed.

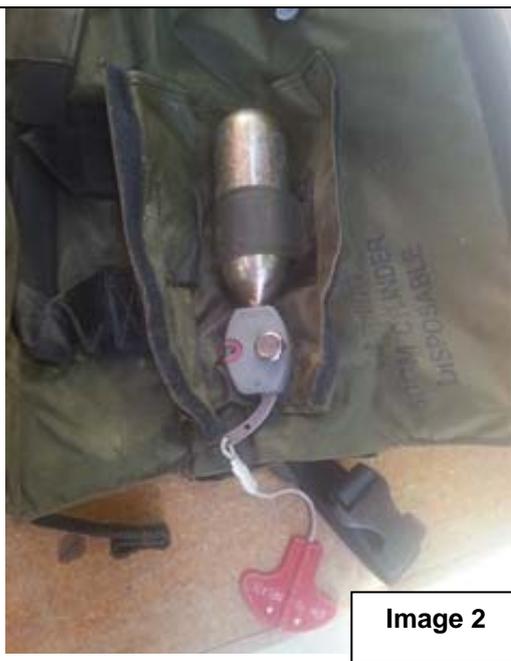
44. The Court finds this of concern from a safety perspective. Regardless of whether or not the gas canister has been activated, any life jacket showing red on the canister mechanism should be deemed unserviceable and sent for repair and servicing.

Image 2 shows the same system however the valise has been opened and the red safety indicator can be observed.

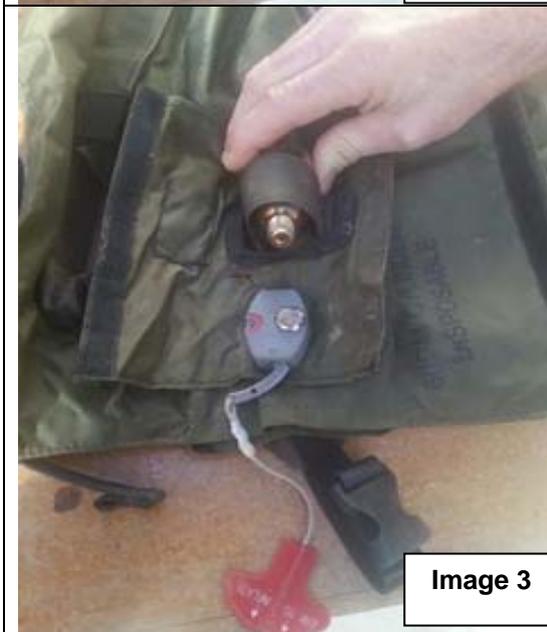
Image 3 shows the gas canister removed and clearly 'struck' after being activated by the firing lever.

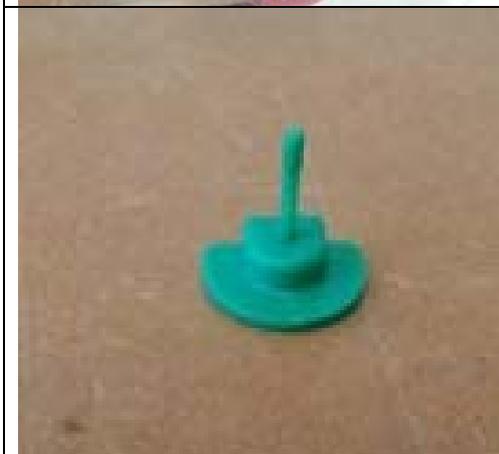
This is the type of plastic safety clip that was missing from Private Ross' life jacket. This plastic pin passes through the firing head body and firing level to act as a resistive force against inadvertent deployment of the jacket as well as a visible indicator that the jacket has not been previously deployed. This clip would normally be ejected from the firing head when the firing lever is pulled.

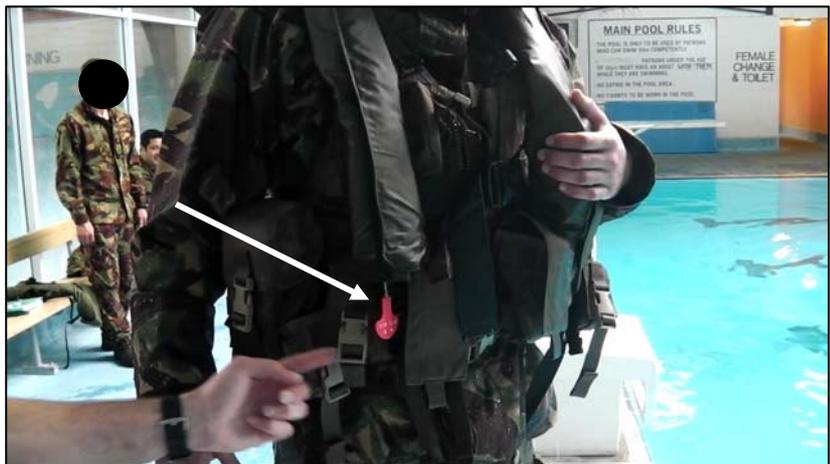
Figure 8: RFB 60B life jacket with toggle exposed

46. **Wearing technique.** With the life jacket correctly worn over the webbing vest and a weapon slung across the body it is extremely difficult to locate and operate the red toggle to activate the life jacket. The bottom of the life jacket sits just above the waistline of an individual and in line with the webbing straps. It is covered by the slung weapon. To become proficient in the activation of their life jackets, personnel must conduct training and rehearsals to gain confidence in locating the toggle and activating the life jacket.

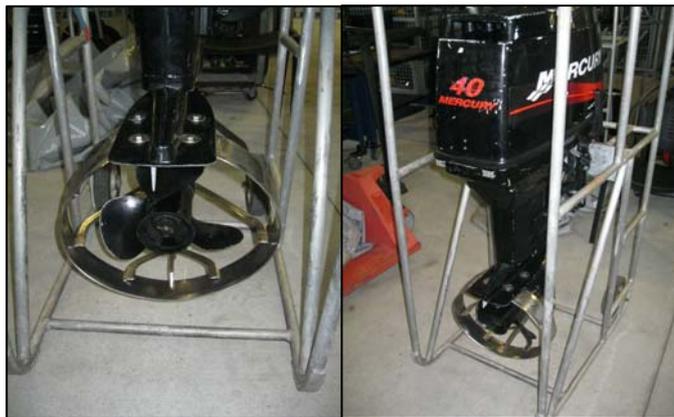
Figure 15: RNZN Outboard Motors with Propeller Guards

98. The Court finds that neither the Zodiac nor the TSB safety boat had propeller guards.¹⁴¹ The Mercury 40HP Outboard Motor that is utilised by the RNZN is supplied with propeller guards as a standard fit as shown in Figure 15.¹⁴² As this EIC activity involved both the Zodiac and the safety boat being capable of conducting rescue activities, the Court considers a propeller guard should be attached to both types of boat, accepting that the standard operating procedure (SOP) was to put the vessel into neutral, in the event of a recovery.¹⁴³ In this incident the Water Safety Officer was able to engage Neutral on the safety boat when attempting to rescue Private Ross.
