OIA-2023-4701

1. Court of Inquiry into the TA-4K Skyhawk NZ 6253 aircraft incident
2. Article from a safety publication on the TA-4K Skyhawk NZ 6253 aircraft incident

PROCEEDINGS OF A COURT OF INQUIRY OR
INVESTIGATION INTO AN AIRCRAFT INCIDENT

Assembled on 26 March 1981 at RNZAF Ohakea
(Date) (Place)By order of Air Officer Commanding Operations Group RNZAFTo inquire into the incident involving aircraft TA4K NZ6253 on 25 March 1981
(Type and Number) (Date)

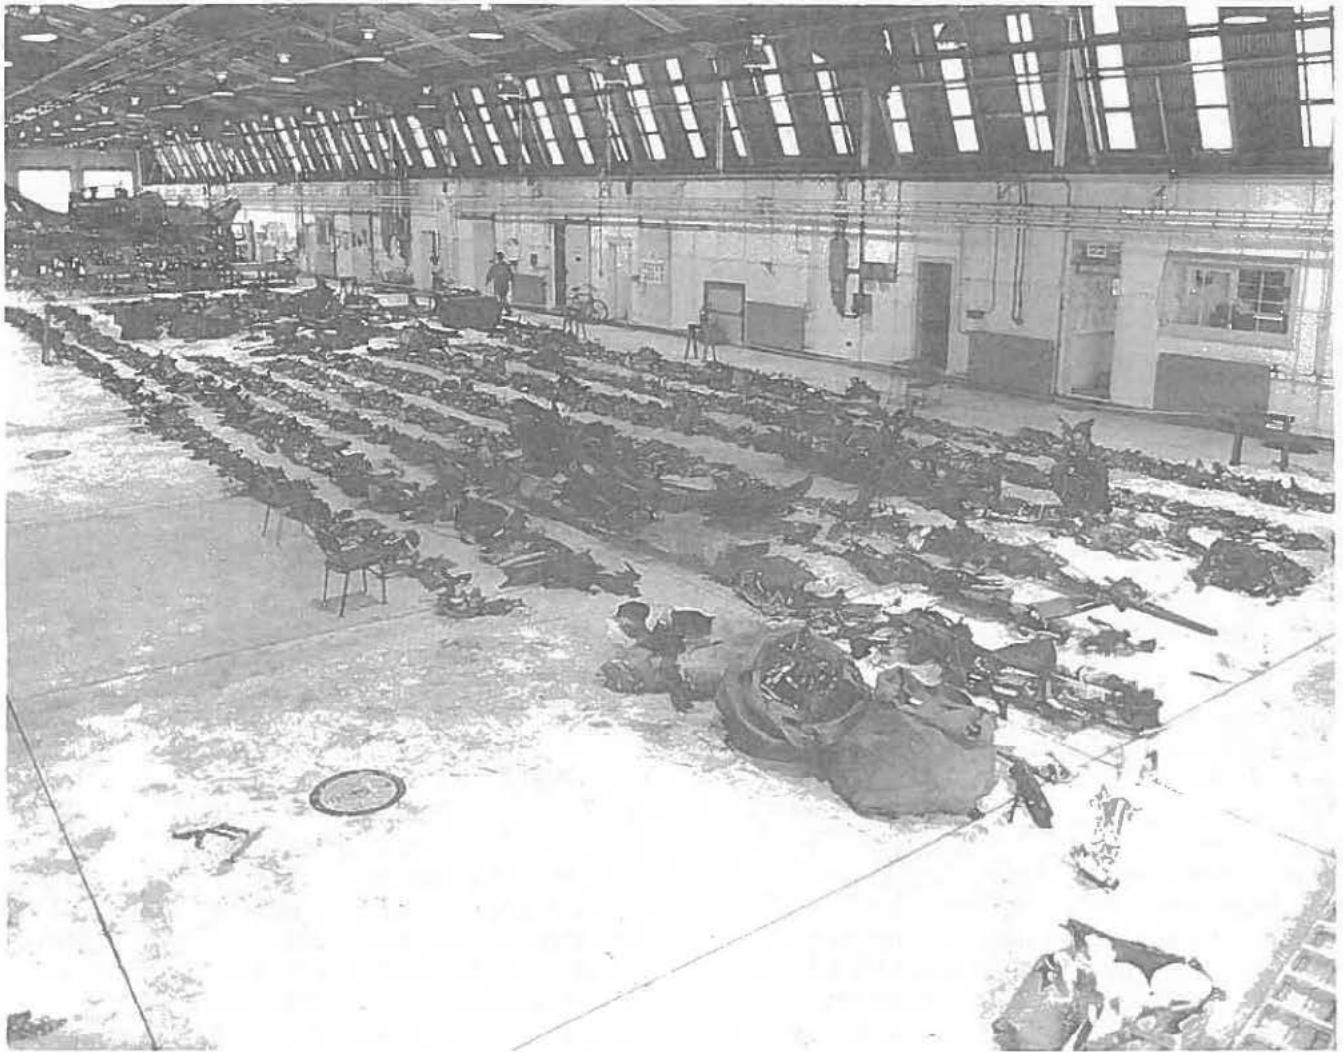
FATAL CRASH

The crash of Skyhawk NZ 6253 on 25 March 1981 was the first fatal aircraft accident in the RNZAF since 1973. The accident occurred in rugged terrain, in the Ruahine Ranges, approximately 20 miles north-east of Taihape. The absence of eye-witnesses, the rugged terrain and the degree of disintegration required the most comprehensive accident investigation undertaken by the RNZAF in recent years, in an attempt to establish the cause of the accident.
