REPORT OF THE COURT OF INQUIRY

Executive Summary

1. (U) On 12-13 October 2017, D Squadron of 1 NZSAS Regiment were conducting a regular Maritime Counter Terrorism (MCT) exercise with the Motor Vessel (MV) Olivia Maersk. During the conduct of this activity, an accident occurred that resulted in the death of M995290 SGT W.R. Taylor, RNZIR.

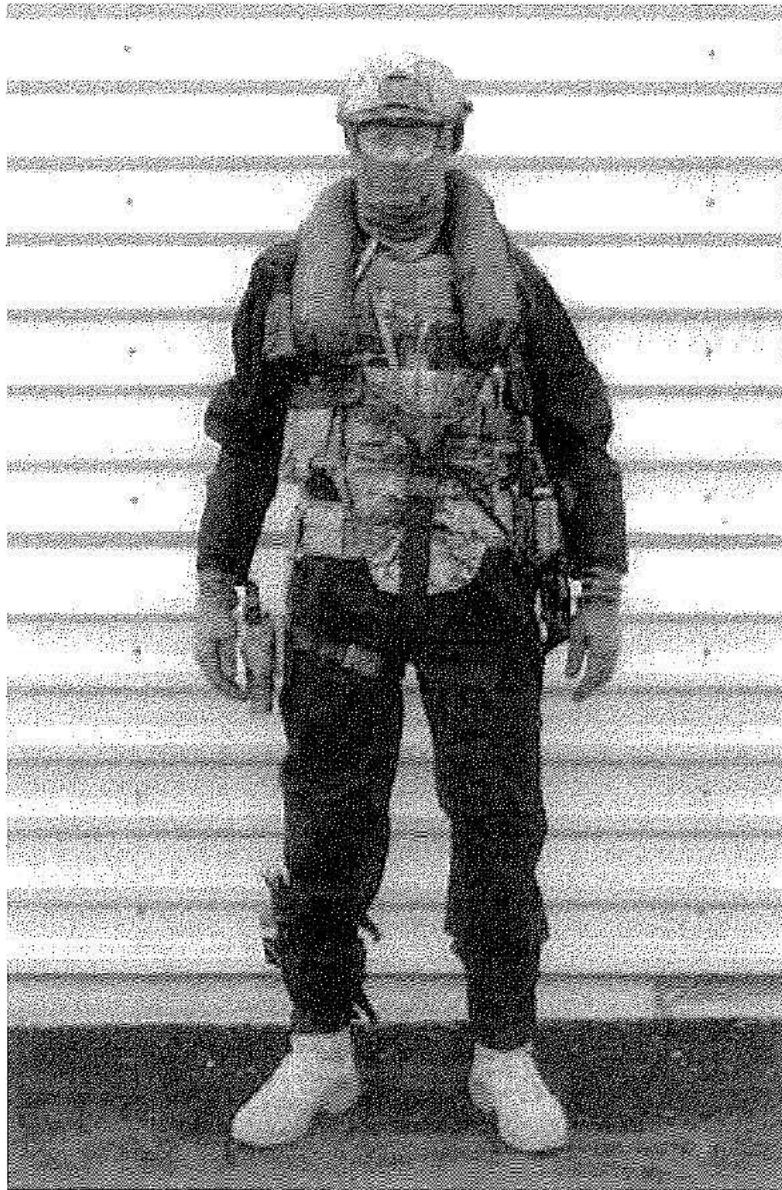
(R) Fig 10 Representative Configuration of Equipment worn by SGT Taylor⁴⁵⁰

152. (D) The Court finds that SGT Taylor was wearing standard assault equipment with some minor personal additions: ⁴⁴⁴
- a. Bump Helmet serial No 07616010;
 - b. s. 6(a)
 - c. Helmet mounted strobe light;
 - d. FRIS Suit; ⁴⁴⁵
 - e. Boots;
 - f. Body Armour s. 6(a)
 - g. Weapon Sling;
 - h. HK MP5 s. 6(a) (Machine Gun) Configured for SIMFIRE;
 - i. Pistol belt and holster;
 - j. Glock SIMFIRE Pistol;
 - k. s. 6(a) HK MP5 Magazine with SIMFIRE ammunition;
 - l. s. 6(a) 5.56 Magazine with s. 6(a) SIMFIRE ammunition;

- m. Knife & Marine Flare;
 - n. 5 Cyalume chemical lights⁴⁴⁶;
 - o. ISP Mk 3 363N Special Forces Life Jacket Serial No 1482018;
 - p. Webbing;
 - q. s. 6(a) Radio & headset;
 - r. Strike Face Mask;
 - s. s. 6(a) and
 - t. Watch.
153. (U) Fig 10 is representative of the configuration SGT Taylor was wearing. s. 6(a) checked SGT Taylor's equipment configuration immediately ahead of the exercise; there were no anomalies noted.⁴⁴⁷
154. (U) The Court finds that SGT Taylor's equipment was configured in a standard fashion that was well-established and trusted by the operators;⁴⁴⁸ all the assault equipment he was using had been introduced into service.⁴⁴⁹
