OIA-2026-5806

1. Toxic Gas Incidents between 23-28 November 2022 in HMNZS Te Mana
2. Two RNZAF UNIMOG's rolling over in August 2024
3. Injury during live firing practice, Ardmore MTA

**REPORT OF THE COURT OF INQUIRY  
REGARDING  
TOXIC GAS INCIDENTS BETWEEN 23-28 NOVEMBER 2022 IN HMNZS TE MANA**

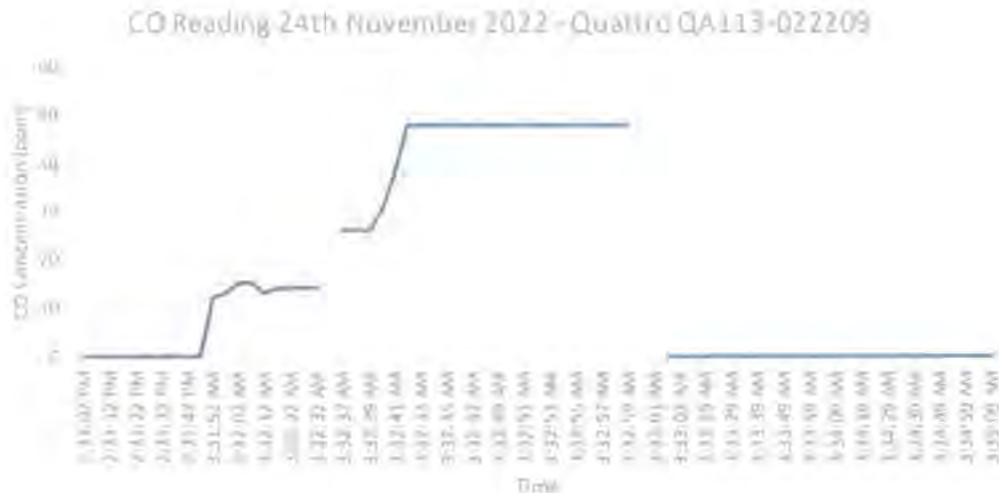
Figure 3 – CO Reading 24 Nov 22

- a. **Likely Exposure Time.** For Incident Two, the Quattro detected CO for a period of only 72 seconds,<sup>98</sup> during which time the CO level increased from 0 ppm to 48 ppm at its maximum and then plateauing (see Figure 3).<sup>99</sup>

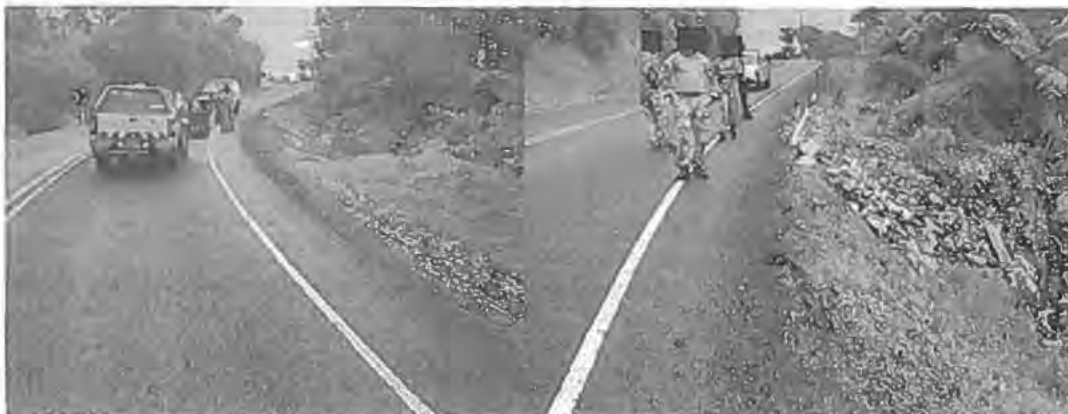
Photograph 1. Extract from Exhibit 15 G and Exhibit 16 C.

15. South Head Road in the vicinity of the crash site is a two lane, sealed road in good condition (Photograph 1) with a posted legal speed limit of 80kph. The section of road where the rollover occurred is subject to a NZTA hazard warning and recommended reduced speed advisory, with motorists advised to reduce speed to 45kph for the next two kilometres. There was no other traffic and no roadworks in the area at the time of the crash. The road surface was wet having rained earlier that morning.<sup>6</sup>

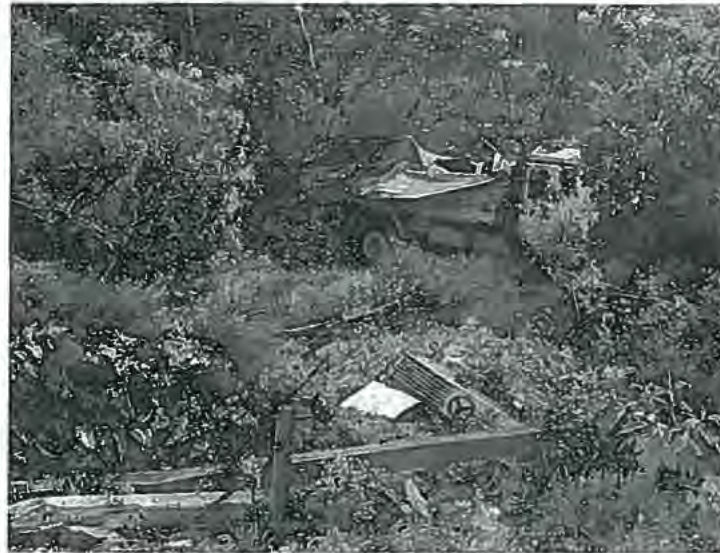
Photograph 2. Extract from Exhibit 11 K.

16. Witness 7 gave evidence that approximately 20 minutes after leaving Parakai he was driving UNIMOG s. 9(2)(k) on a downhill section of winding road, through an S bend when just past the apex of the bend he felt the rear of the UNIMOG slide out.<sup>7</sup> He estimates his speed to be 62 to 65 kilometres per hour<sup>8</sup> (the Court was presented ERoad data recorded from the UNIMOG that confirmed the vehicle speed was 64kph immediately before the rollover).<sup>9</sup> The UNIMOG fishtailed and fearing the vehicle would roll down the bank on the left, Witness 7 stated he steered toward a power pole hoping it would arrest the vehicles forward momentum. The UNIMOG however severed the concrete power pole and rolled down the bank two to three times coming to rest on its wheels in bush approximately 30 meters below the road (Photograph 2). Witness 7 and Witness 8 climbed

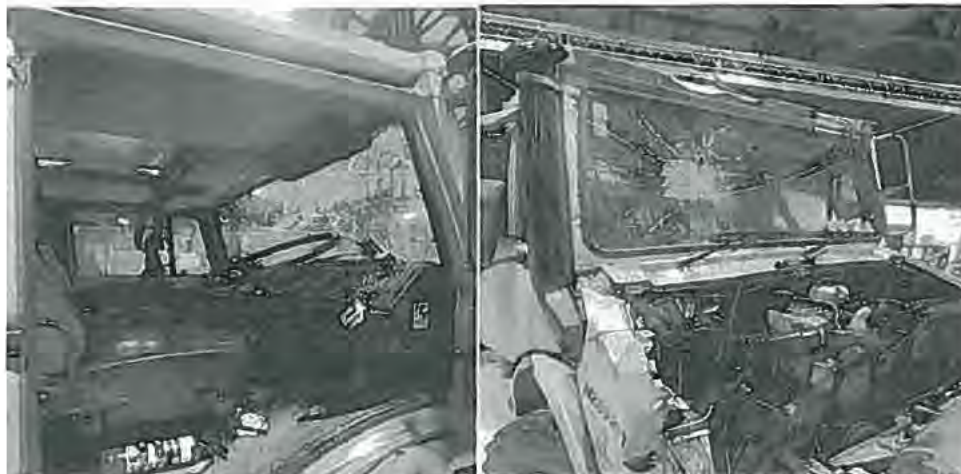
Photograph 5. Extract from Exhibit 16 D.

29. The ROPS of UNIMOG s. 9(2)(k) functioned as designed fully protecting the occupants of the cab as the vehicle rolled multiple times. The ROPS itself suffered minor damage to the structure running across the top of the windscreen but otherwise the ROPS maintained its full integrity (Photograph 5).

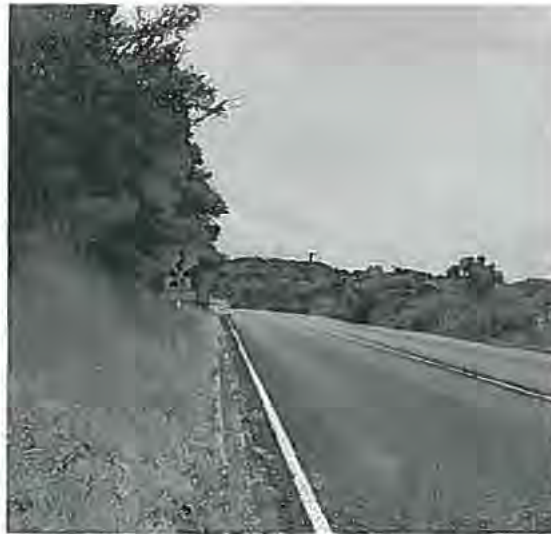
Photograph 4. Extract from Exhibit 15 F.

**Finding 6:** Acknowledging that the road was wet, the Court finds no evidence of any unknown or unavoidable factors with the road or environment that may have contributed to the rollover. The Court finds the inherent hazard of this section of road to be prominently and permanent identified by NZTA warning signs that advise motorists to reduce speed.

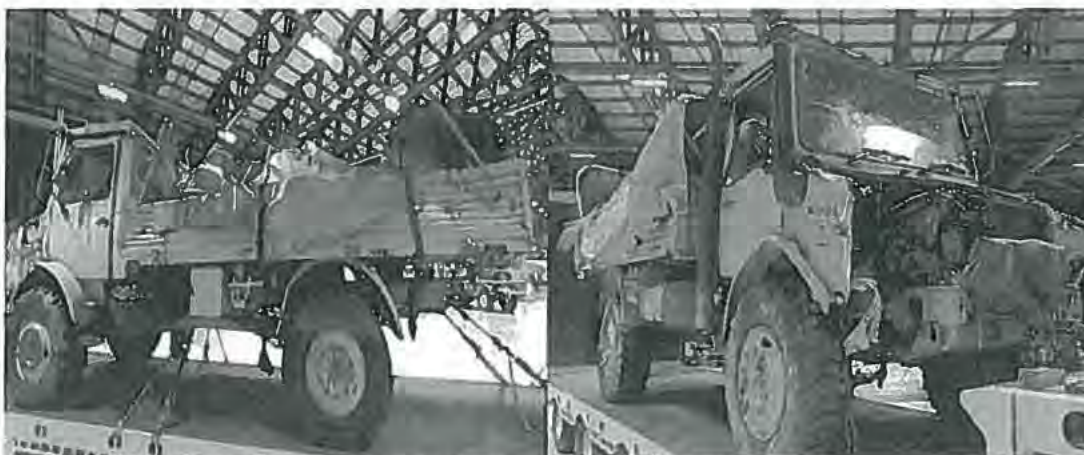
Photograph 3. Extract from Exhibit 16 D.

64. UNIMOG s. 9(2)(k) suffered significant damage because of the incident the vehicle will be written off and disposed of in due course (Photograph 3). A claim for the vehicle was lodged with NZI on 21<sup>st</sup> August 2024 as part of VICRS reporting; claim number s. 9(2)(k).<sup>64</sup>

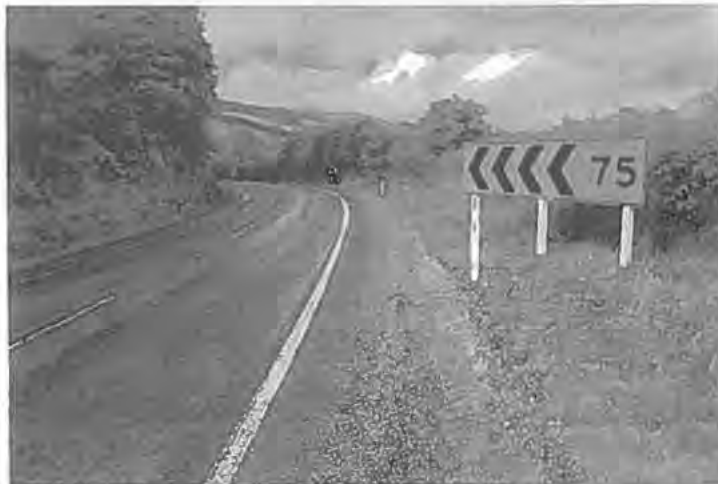
Photograph 6. Extract from Exhibit 6 I.

67. State Highway 65 in the vicinity of the rollover site is a two-lane sealed road in fair to good condition with a speed limit of 100 kph.<sup>67</sup> On the day of the rollover, the road was wet having rained earlier that morning. There was minimal traffic and no roadworks in the area or loose material on the road at the time of the incident. The Southern approach to the bend is subject to a NZTA hazard warning and recommended reduced speed advisory of 75kph (Photograph 6) and immediately prior the rollover UNIMOG 1 was travelling at 81kph.

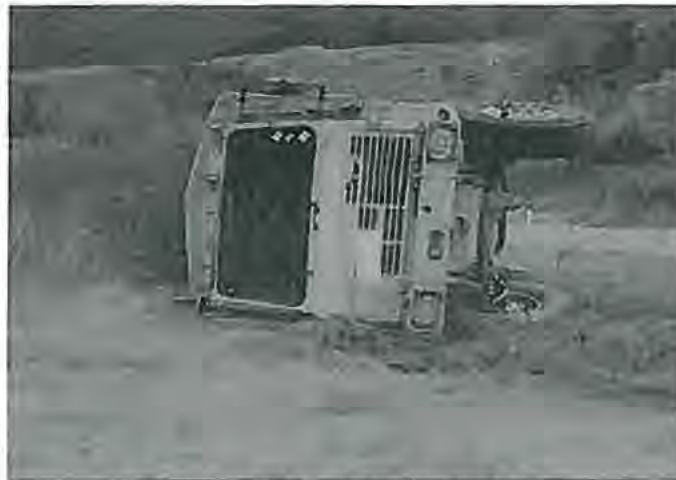
Photograph 7. Extract from Exhibit 6 H.

69. Approximately 20 minutes after departing Murchison Witness 4 stated he arrived at the corner where the rollover happened. Witness 4 stated he was approximately 80% through the corner looking down the exit straight when he felt the rear of the UNIMOG slide out. Witness 4 tried to correct the vehicle, but it skidded to the right and then left, then entered a small ditch, spinning the vehicle 180 degrees and causing the UNIMOG to slowly tip over onto its right side. The UNIMOG came to rest across a wire-strand farm fence (Photograph 7). The rollover caused minor damage to the right-side drivers mirror and door panel and deflated the right rear tyre. Witness 4 stated he was uninjured and after exiting the vehicle he called Witness 3 in the lead vehicle and informed him of the incident.<sup>68</sup>

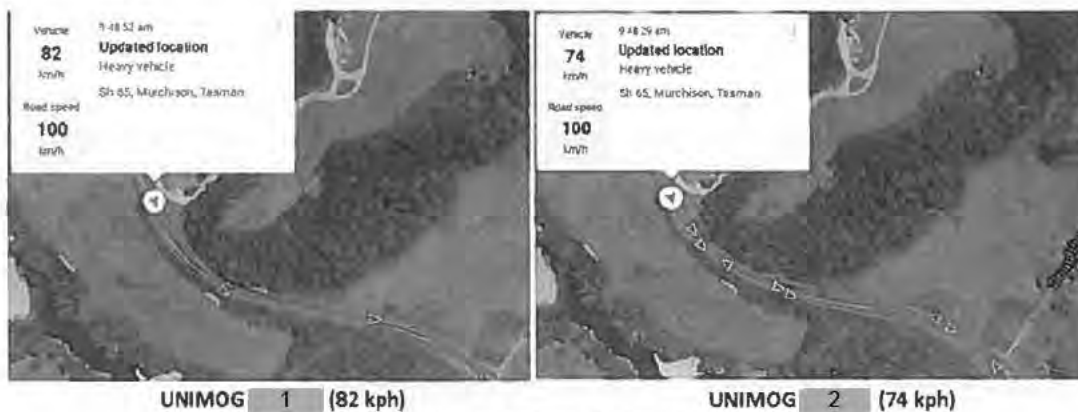
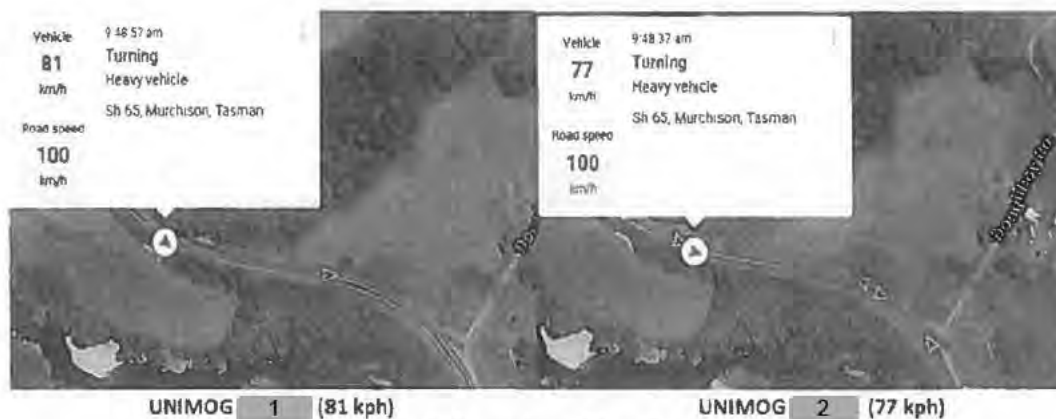
94. Figures 1 and 2 compare the telemetric data transmitted by ERoad for UNIMOG 1 and 2 at the same two points of the corner at (a) entry and (b) apex. Figures 1 and 2 illustrate that 1 was travelling faster than the 75kph advisory speed at both points.

95. That UNIMOG 2 travelling through the apex at 77 kph and successfully negotiated the corner, while UNIMOG 1 travelling through the apex at 81 kph did not complete the corner, suggests vehicle speed was a contributing factor to the roll over, noting the faster a vehicle travels, the greater the overturning (side) forces applied to the vehicle become; the speed-squared-effect.<sup>96</sup>

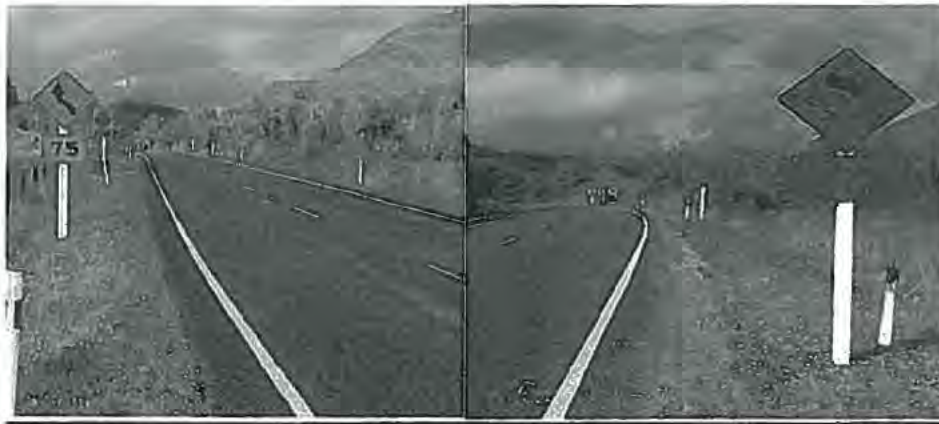
Photograph 8. Extract from Exhibit 6 I.

104. Rollover Site Visit by Witness 6 [s. 9(2)(a)]. Witness 6 concluded two probable scenarios led to the rollover, firstly a loss of traction due to a combination of driver error and speed; and second a loss of traction due to a vehicle fault. Considering the speed of the UNIMOG, slightly above the advisory speed, Witness 6 followed several large vehicles through the corner (speed matched) and noted large vehicles transited the corner at approximately 90kph without difficulty (co-driver reading off the ERoad display). Witness 6 stated Witness 4s driving behaviour was assessed (based off the ERoad data) as showing a disciplined approach and that his driving trend remained the same throughout the whole trip. Witness 6 concluded the loss of traction due to driver error and/or speed was unlikely. On the balance of probabilities, Witness 6 considered the loss of traction due to a vehicle issue was more likely.<sup>105</sup>

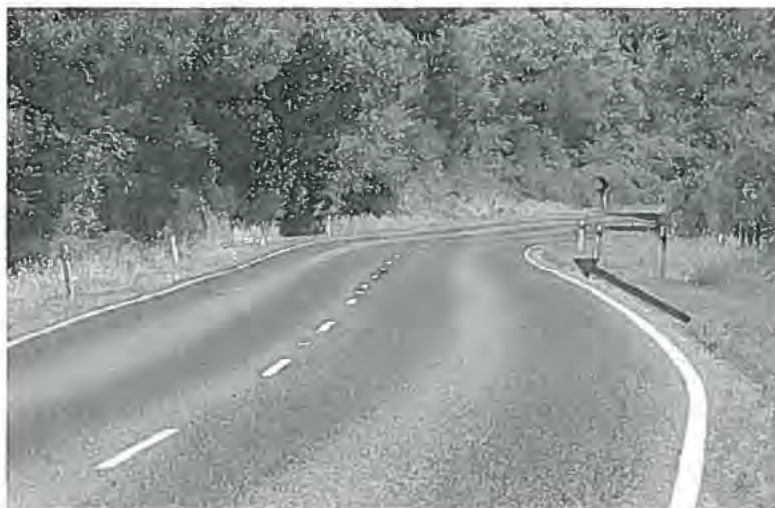
Photograph 9. Taken by COI President. Fri 14th Feb 25.

105. Rollover Site Visit by COI Members: The COI members visited the site of the rollover on 14<sup>th</sup> February 2025 and 20<sup>th</sup> March 2025. Conditions were similar but the Court noted the road had been resurfaced since the rollover. COI members walked in a Southern direction from the corner entry point through to the exit-straight approximately 200m farther down the road. At a point past the apex but before the exit point, the road level and camber of the South bound lane noticeably change within a very short distance.

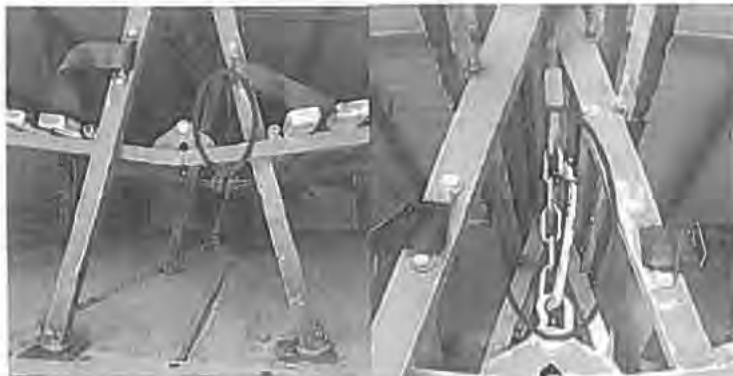
Photograph 10. Extract from Exhibit 1 K.

148. The rear wooden bench seats are side facing with supports fitted directly into slots in the main vehicle cargo deck. The security of seats to the cargo deck is achieved by a chain and turn buckle tensioner set-up, with an over centre safety-link to ensure tension is maintained and seats do not collapse in on themselves. The safety-link is a simple over-centre mechanism that can be disengage by accidental interference from bags or people. With the safety link opened, it is possible for the chain and turn buckle to loosen over time and allow the seat supports to disengage from the cargo deck. The safety link is highlighted in Photograph 10.

**Finding 31:** The Court finds in a crash scenario under high G forces, passengers could be at risk of being thrown around the cargo area even though they remain secured to the seat by seatbelts.

**Recommendation 15:** The Court recommends the Directorate Land Engineering investigate options to replace the current over-centre safety link with a positive-locking mechanism.

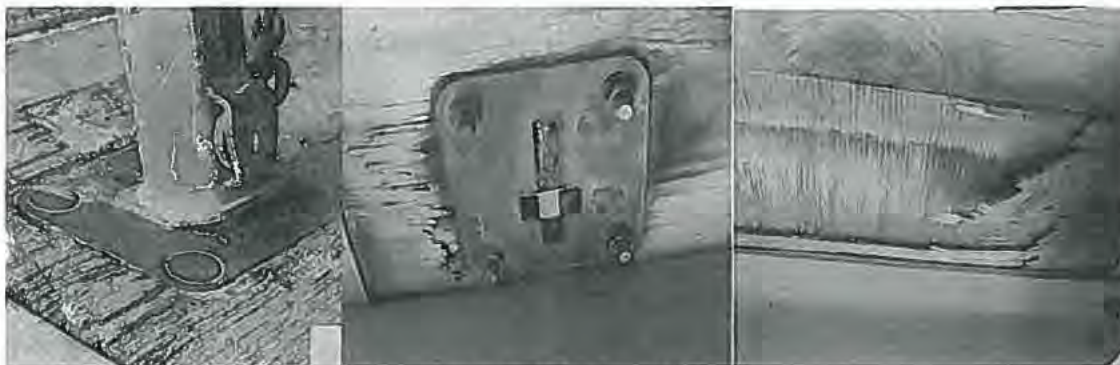
Photograph 11. Extract from Exhibit 1 K.

case of UNIMOG 1 the plywood deck around several metal anchor plates is badly deteriorated and breaking up. The Court heard evidence from Witness 1 that there is no inspection plan or schedule maintenance for UNIMOG cargo decks or seat anchor points. It is up to individual maintenance staff to determine the serviceability of cargo decks and act as necessary. Reference Photograph 11.

**Finding 32:** The Court finds the absence of inspection and maintenance schedule for ageing UNIMOG plywood cargo deck increases the potential for harm to passengers should the seat to cargo-deck interface fail during a rollover or crash.
