OIA-2026-5806

1. Toxic Gas Incidents between 23-28 November 2022 in HMNZS Te Mana
2. Two RNZAF UNIMOG's rolling over in August 2024
3. Injury during live firing practice, Ardmore MTA

**REPORT OF THE COURT OF INQUIRY  
REGARDING  
TOXIC GAS INCIDENTS BETWEEN 23-28 NOVEMBER 2022 IN HMNZS TE MANA**

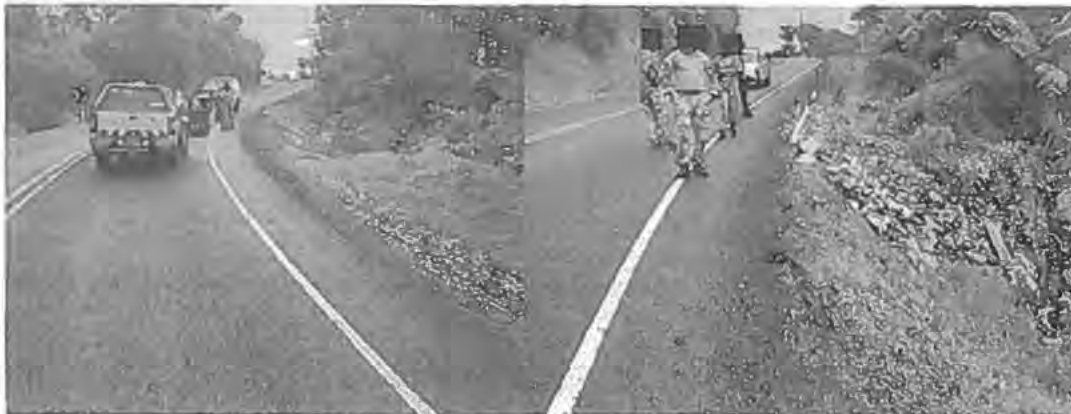
Photograph 1. Extract from Exhibit 15 G and Exhibit 16 C.

15. South Head Road in the vicinity of the crash site is a two lane, sealed road in good condition (Photograph 1) with a posted legal speed limit of 80kph. The section of road where the rollover occurred is subject to a NZTA hazard warning and recommended reduced speed advisory, with motorists advised to reduce speed to 45kph for the next two kilometres. There was no other traffic and no roadworks in the area at the time of the crash. The road surface was wet having rained earlier that morning.<sup>6</sup>

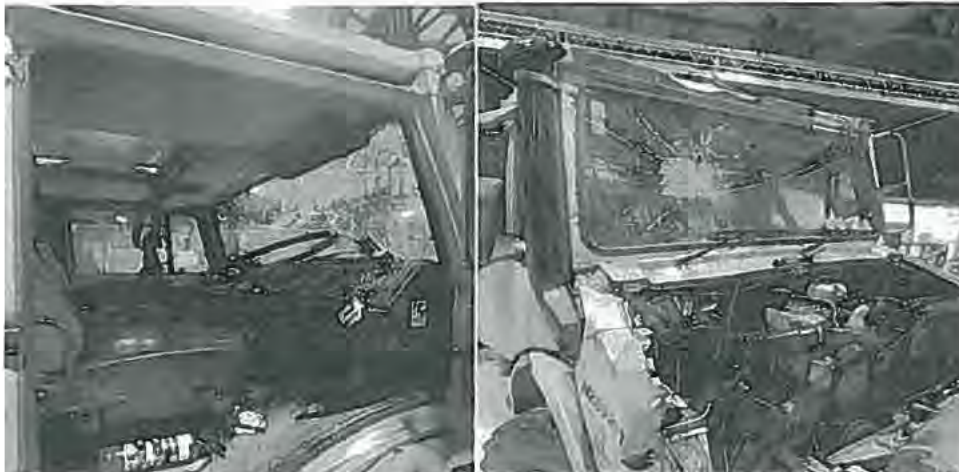
Photograph 5. Extract from Exhibit 16 D.

29. The ROPS of UNIMOG s. 9(2)(k) functioned as designed fully protecting the occupants of the cab as the vehicle rolled multiple times. The ROPS itself suffered minor damage to the structure running across the top of the windscreen but otherwise the ROPS maintained its full integrity (Photograph 5).

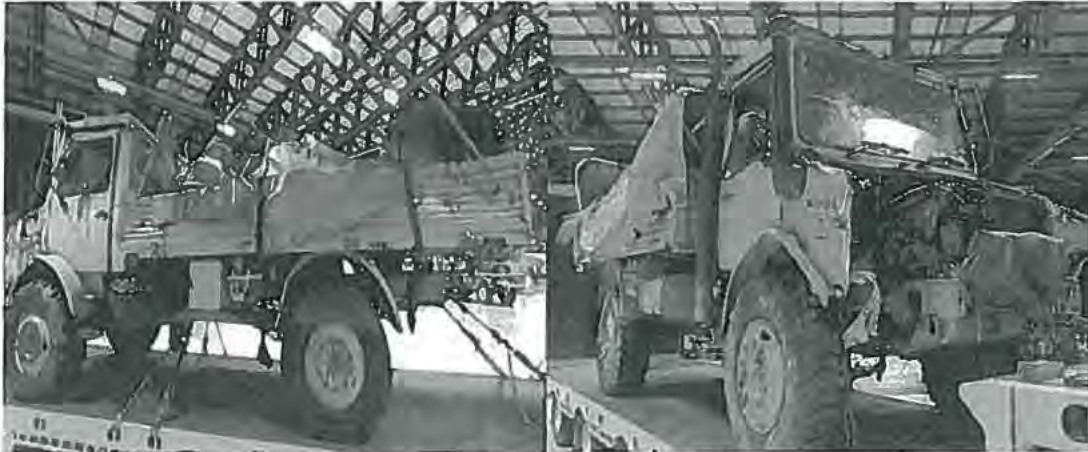
Photograph 3. Extract from Exhibit 16 D.

64. UNIMOG s. 9(2)(k) suffered significant damage because of the incident the vehicle will be written off and disposed of in due course (Photograph 3). A claim for the vehicle was lodged with NZI on 21<sup>st</sup> August 2024 as part of VICRS reporting; claim number s. 9(2)(k).<sup>64</sup>

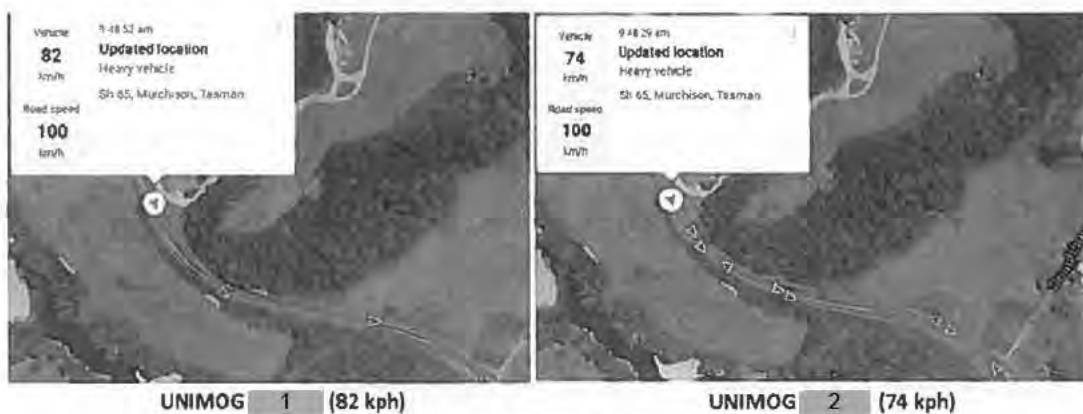
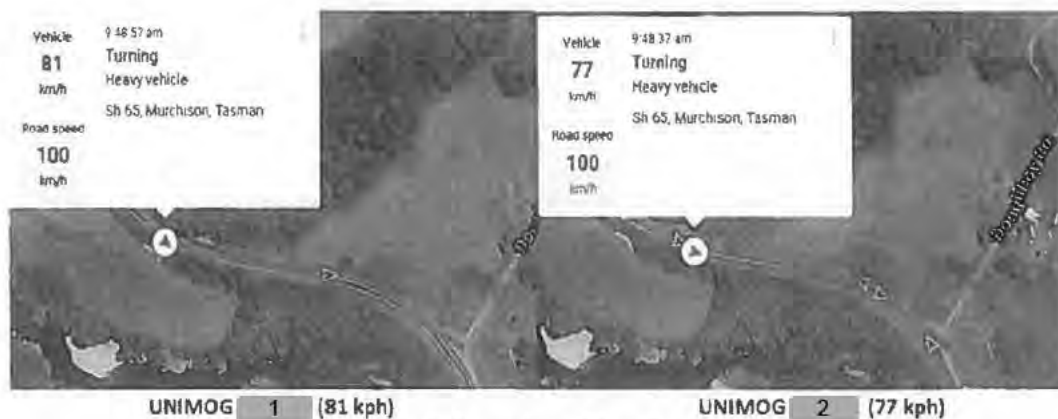
94. Figures 1 and 2 compare the telemetric data transmitted by ERoad for UNIMOG 1 and 2 at the same two points of the corner at (a) entry and (b) apex. Figures 1 and 2 illustrate that 1 was travelling faster than the 75kph advisory speed at both points.

95. That UNIMOG 2 travelling through the apex at 77 kph and successfully negotiated the corner, while UNIMOG 1 travelling through the apex at 81 kph did not complete the corner, suggests vehicle speed was a contributing factor to the roll over, noting the faster a vehicle travels, the greater the overturning (side) forces applied to the vehicle become; the speed-squared-effect.<sup>96</sup>

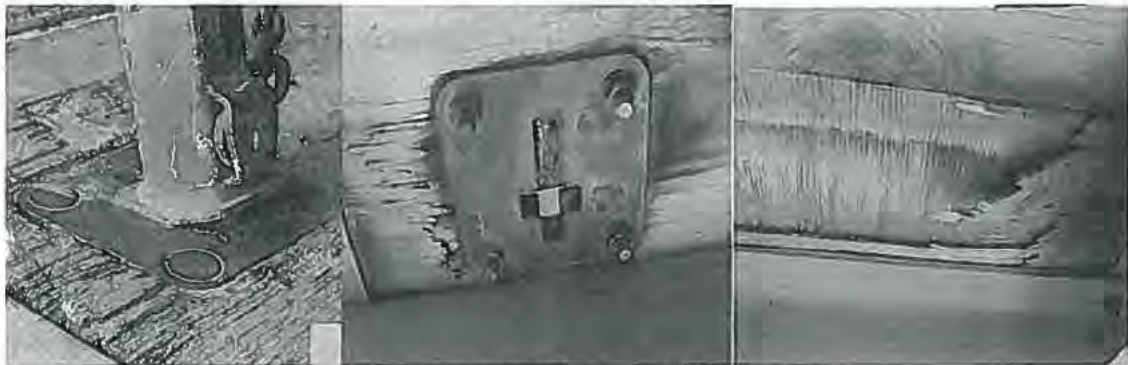
Photograph 11. Extract from Exhibit 1 K.

case of UNIMOG 1 the plywood deck around several metal anchor plates is badly deteriorated and breaking up. The Court heard evidence from Witness 1 that there is no inspection plan or schedule maintenance for UNIMOG cargo decks or seat anchor points. It is up to individual maintenance staff to determine the serviceability of cargo decks and act as necessary. Reference Photograph 11.

**Finding 32:** The Court finds the absence of inspection and maintenance schedule for ageing UNIMOG plywood cargo deck increases the potential for harm to passengers should the seat to cargo-deck interface fail during a rollover or crash.
