# NZDF Nationwide Asbestos Survey Project – Surveyor Manual

- Prepared for  
New Zealand Defence Force

- January 2022

- FINAL Version 2.0

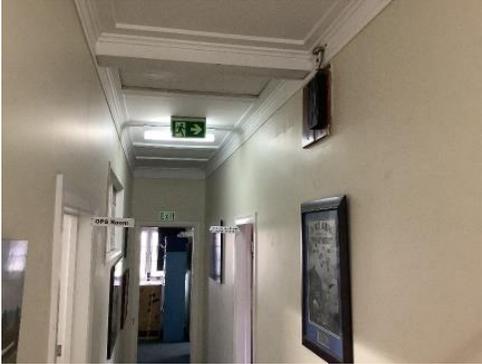
<p style="text-align: center;">Example of <b>Photo 1</b></p>

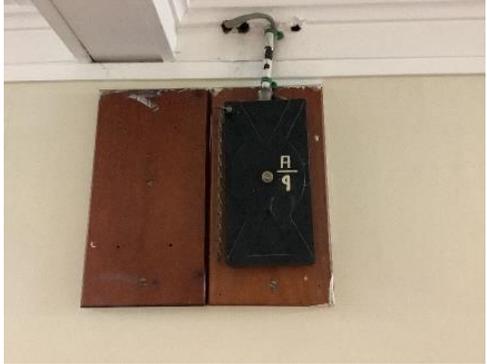
<p style="text-align: center;">Example of <b>Photo 2</b></p>
<p>The format of the photos must be as follows:</p> <ul style="list-style-type: none"> <li>• <b>4.6a Photo 1</b> must show the position of the item/material within the local room/area and must clearly indicate the accessibility of the item.</li> <li>• <b>4.6b Photo 2</b> must show a close-up of the material and must be of suitable quality to identify the product type, and surface condition of material.</li> </ul> <p>See Section 4.2.6 for more information on photography and requirements.</p>

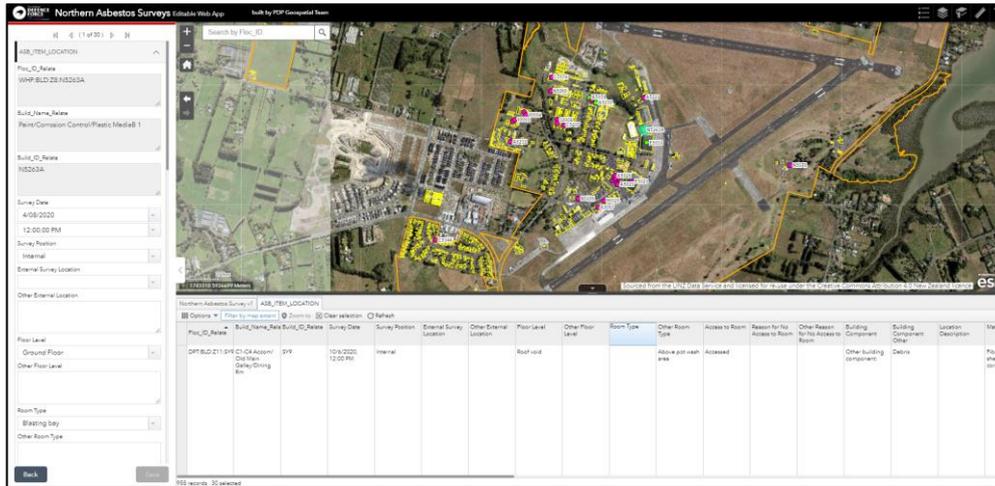
**Figure 3: Comparing selected item record with other items at same location**

The table can be sorted in order of any of the field columns shown by clicking on the column header and selecting “Sort ascending” or “Sort descending”. This can be useful for comparing record entries in the editable item record. Note that data cannot be edited within this table, only in the record display on the left (see *Figure 3*).

The main use for the editable item records is to make amendments following the receipt of bulk sample analysis. The Asbestos Surveyor can change the “ASB Sample Results” to Positive and Negative as required. All fields which are not applicable for a negative-asbestos material (quantity, friability and risk scores (incl. product type)) must be replaced by “N/A” if not originally selected. If the high-risk alert note is filled out, this must be deleted if the item is not asbestos. “ASB in air” and “ASB in soil” should be changed to “No”, and any comments associated with remediating the material (when assumed to be positive) should also be amended accordingly. (See *Figure 4* for image of complete sampled negative item record).

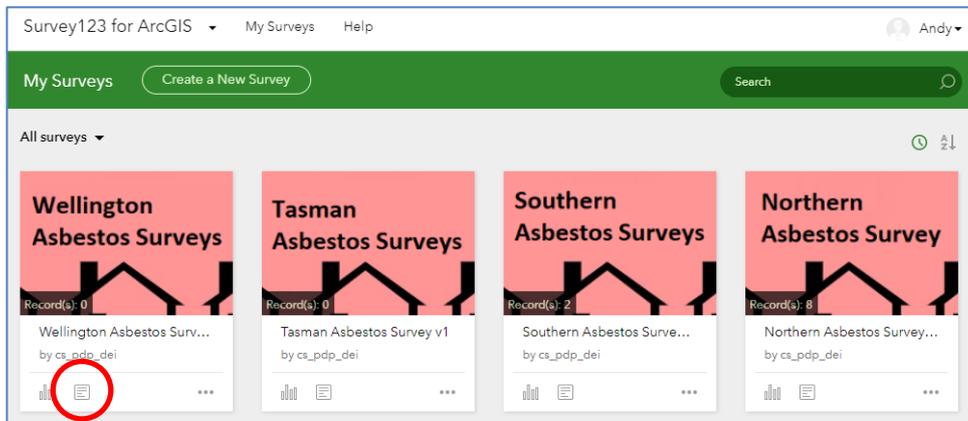
**Figure 5: Different surveys on Survey123 Web Page front page**

beneath the App they have been using (see *Figure 5*) to see a summary of data collected using this survey. (Clicking on the pink box section may show a page without any data displayed.)

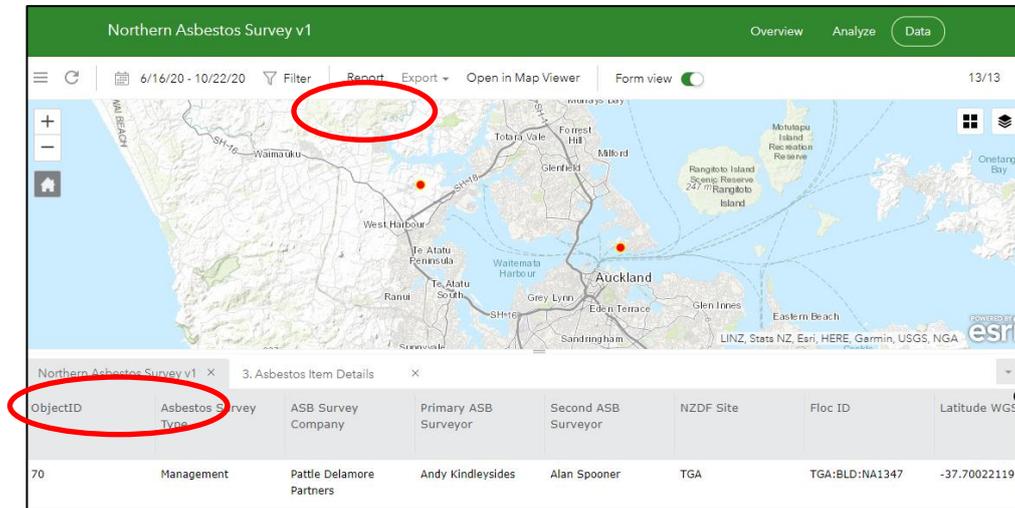
**Figure 6: Geographic display of surveyed properties**

Red icons will show which buildings have been surveyed (only buildings surveyed under the login used to access the Web Page are visible to the user). The *Asbestos Survey* tab should be selected (shaded grey), resulting in building information being listed at the bottom of the screen in a spreadsheet table (if 3. *Asbestos Item Details* is selected, this will show all the individual materials found instead and the report will not be generated correctly). This table can be sorted by clicking on the relevant header to assist with searching for a particular building. (see *Figure 6*)

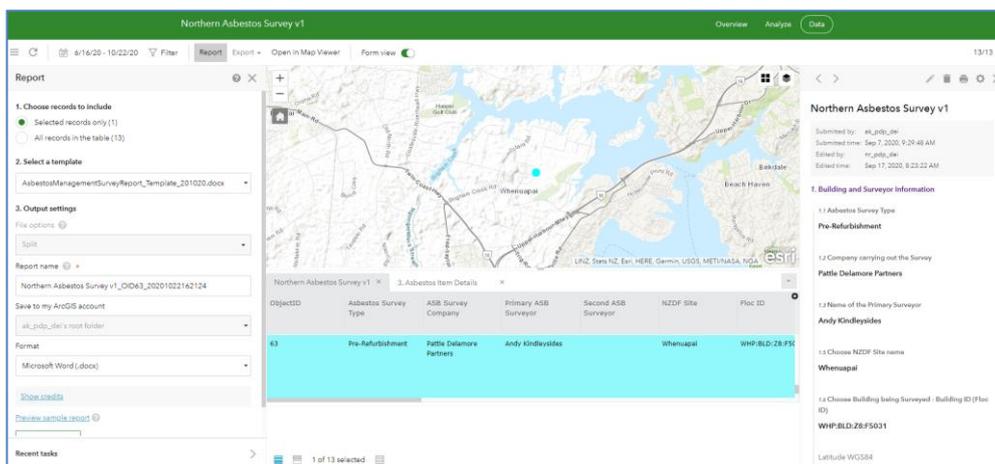
**Figure 7: Report generator shown for selected property**

Click on a red dot or a spreadsheet line entry, which will bring up survey data on the right-hand site. Click on *Report* at the top of the page to show the report generator dialogue box on the left. (See *Figures 7 and 8*)

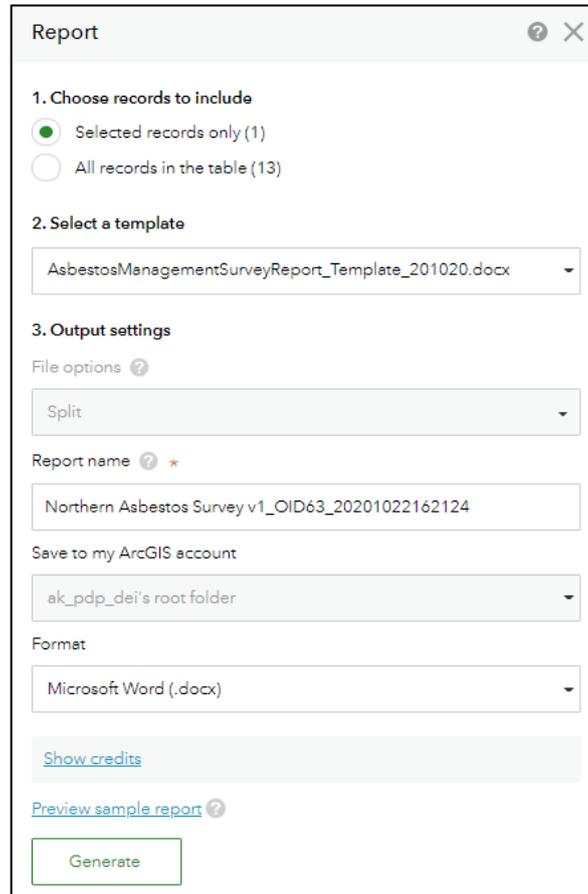
**Figure 8: Report generator options window**

*1. Choose records to include:* Default selection is for “Selected records only”, which will produce item records for the selected building only.

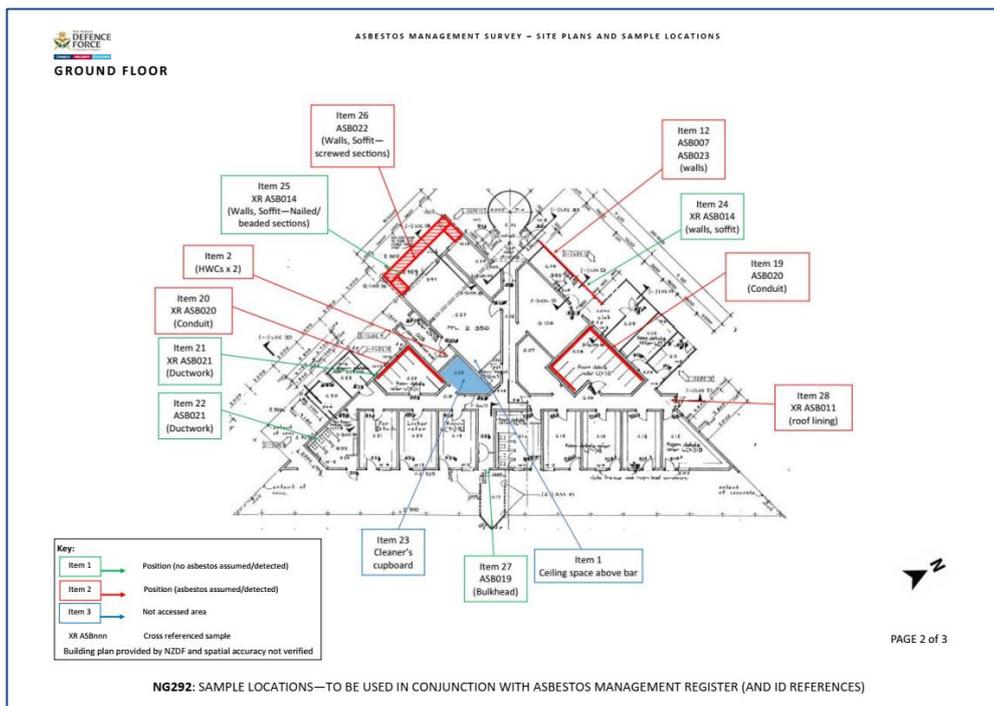
**Figure 10: Example of annotated floor plan figure**

Below (Figure 10) is an example of the minimum requirement for an annotated floor plan figure. A figure (showing every level of a building/structure) must be included with all reports.

Each floor plan can be created using the surveyor's preferred document editor. Once complete, they can be incorporated into NZDF approved figure templates which are generated separate to the main AMS register. These templates include standardised details including a key and caveats.

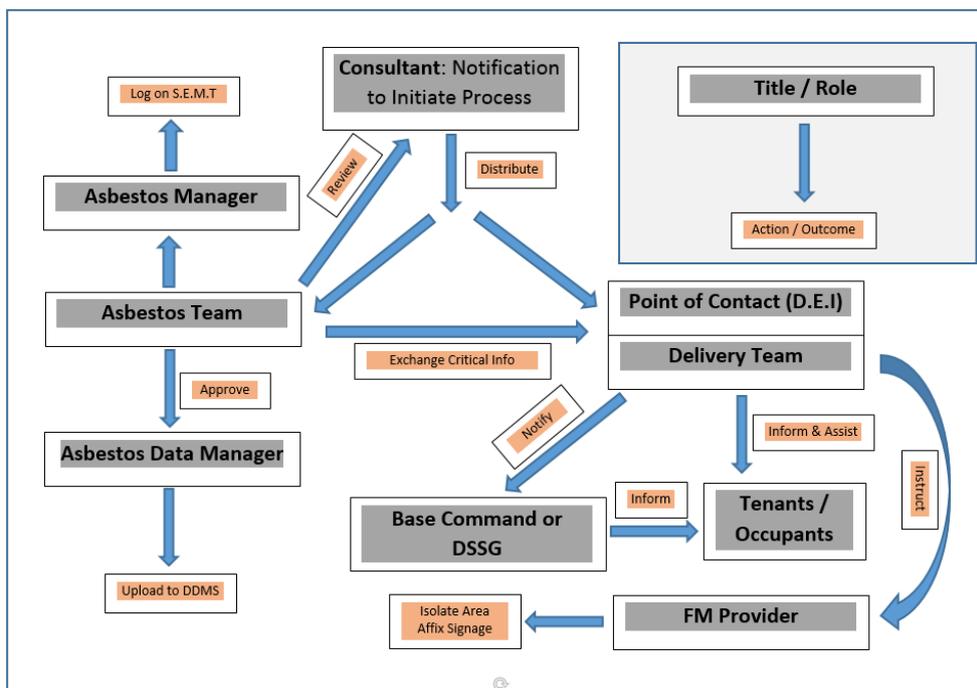
**Communication process for Particular Asbestos Risk Notifications requiring access restrictions to materials / isolation of areas or buildings.**

1. The consultant undertaking the survey must fill in the Asbestos Particular Risk Notification form and send to the Asbestos Team at [asbestos@nzdf.mil.nz](mailto:asbestos@nzdf.mil.nz) and their National Asbestos Survey Programme (NASP) POC within 24 hours of the risk becoming evident (this may be prior to or once sample analysis results received). Where exposure is ongoing a verbal notification must be immediate.
