OIA-2026-5718

BARRACKS AND MESSES AT RISK OF FAILURE AT ALL CAMPS AND BASES

Summary of all barrack and mess buildings that have failed (or indicate risk of failure)

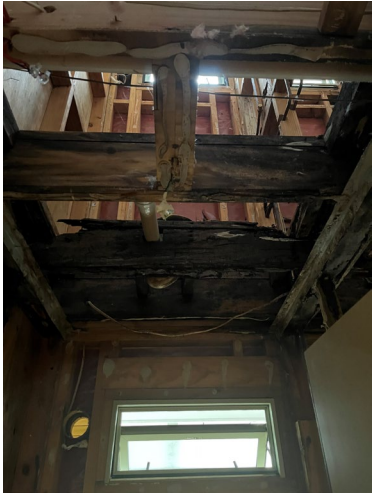
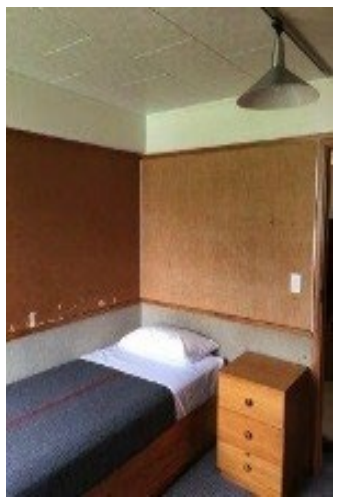
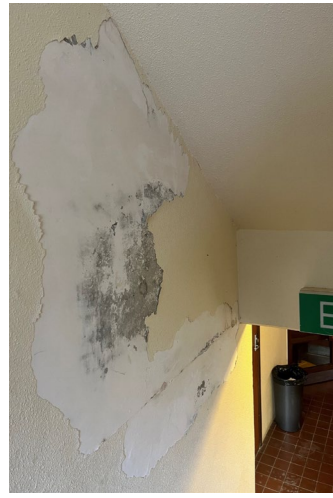
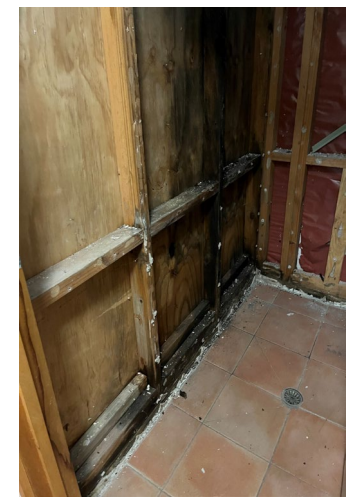
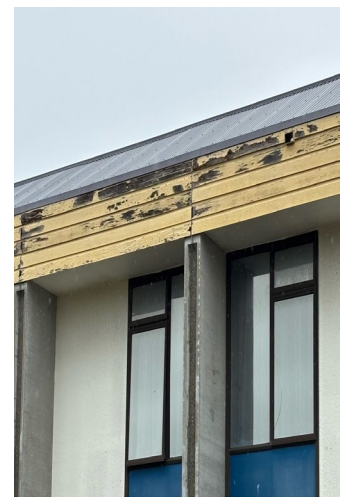
Asset condition photos

The biggest operational risk at Linton is a lack of redundancy for the only remaining mess kitchen, which has a very high level of unscheduled maintenance. The Linton team are conducting thermal imaging on the Officers mess (closed due to water leaks) to establish the extent of the moisture ingress and associated damage.

The Linton team would like to be able to do thermal imaging testing across all barracks.

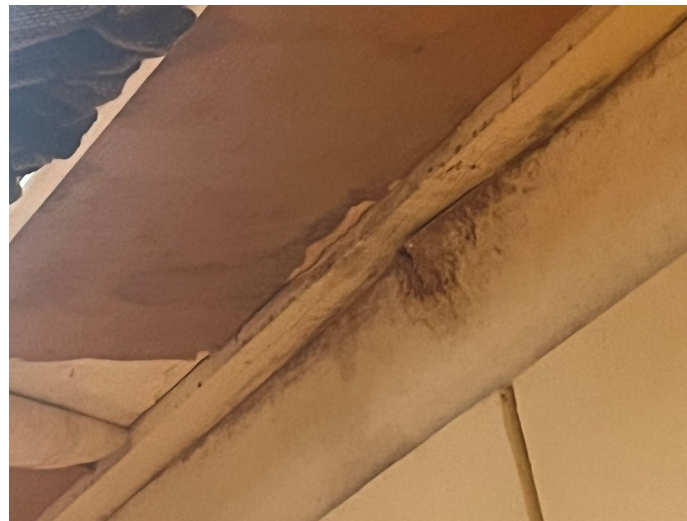
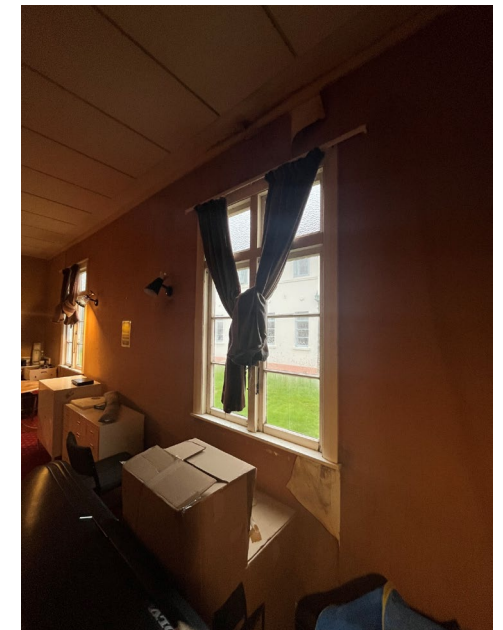
Asset condition photos

Whilst many barracks are not 'fit for purpose' they are mostly dry and warm, although the officers mess (all wings) would benefit from moisture testing to understand the extent of the degradation from closed wing and other moisture sources.

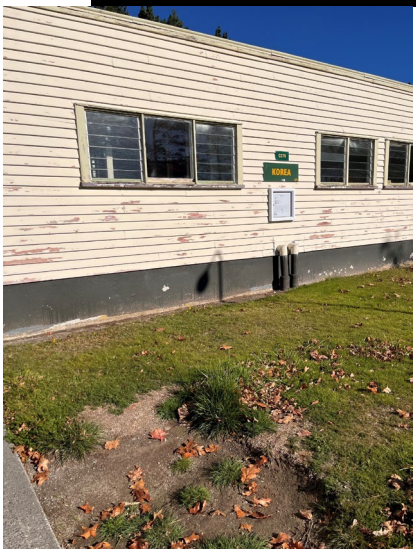
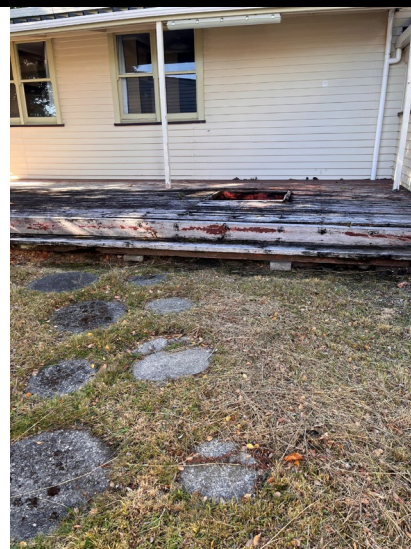
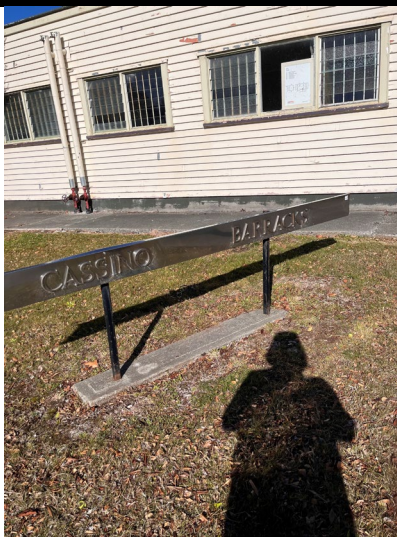
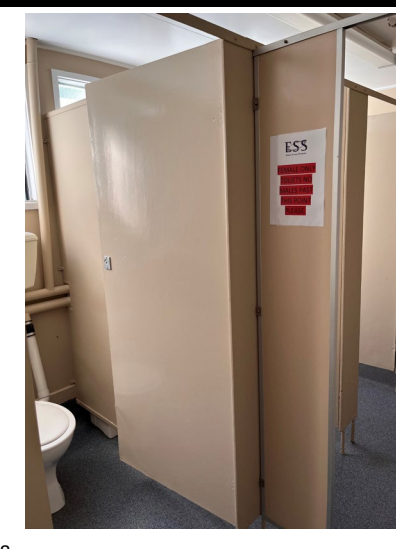
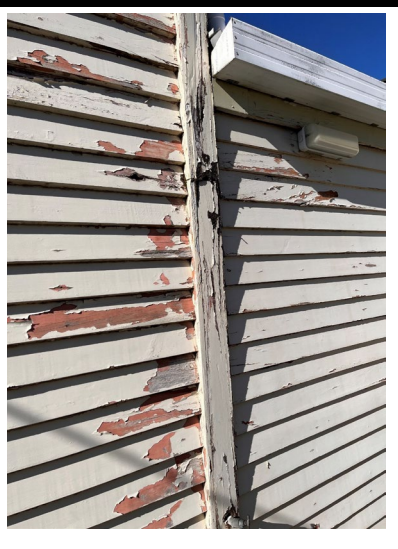
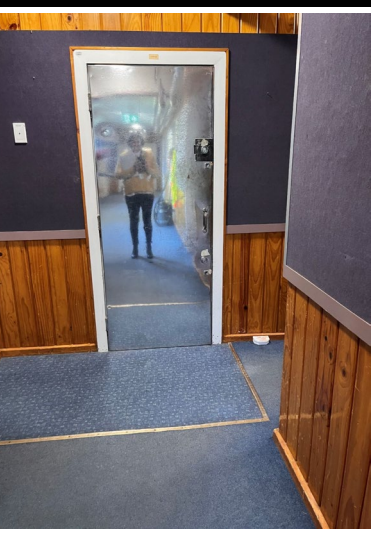
Asset condition photos

The team at Waiouru continue to work on upgrading barracks and mess facilities. The concerns raised are almost all around external condition, the lack of funding to paint and repair raises concerns around weathertightness

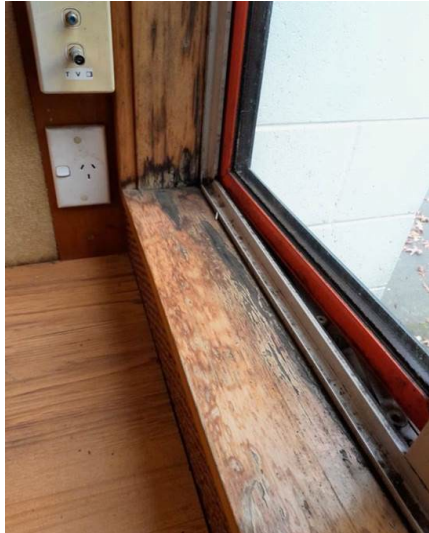
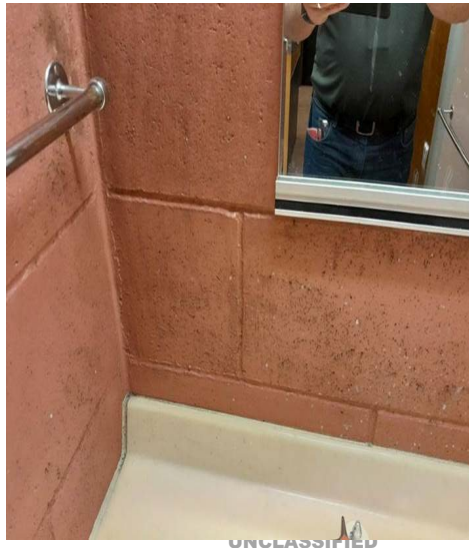
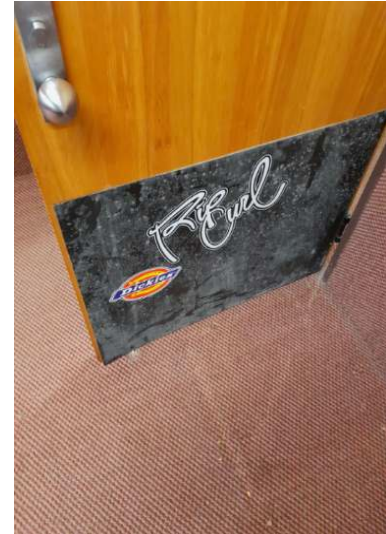
Asset condition photos

Some Chalet barracks that have indicators of risk will need to be demolished to make space for RSF.

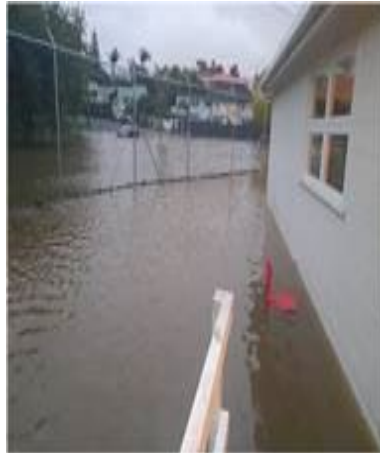
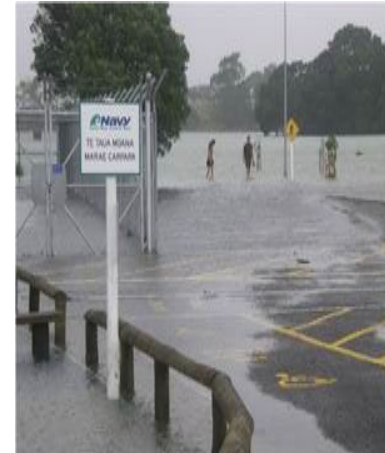
Asset condition photos

Barracks			Messes		Comment
Asset	Out of Service	At Risk	The messes at Devonport -		
Barrack	0	3	• Number of Messes	3	
			• Number of Kitchen	2

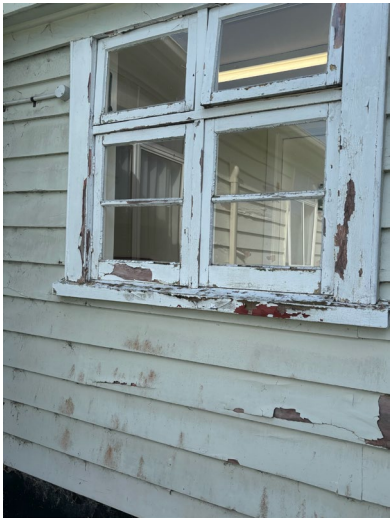
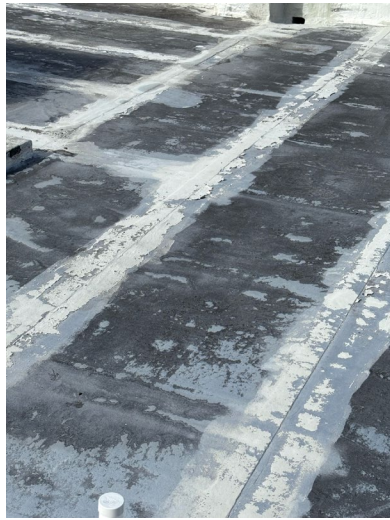
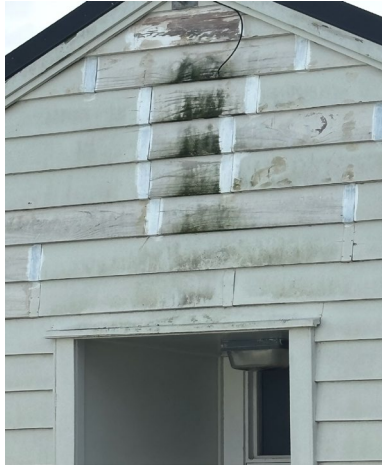
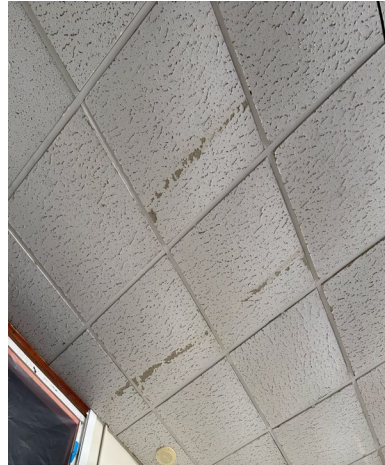
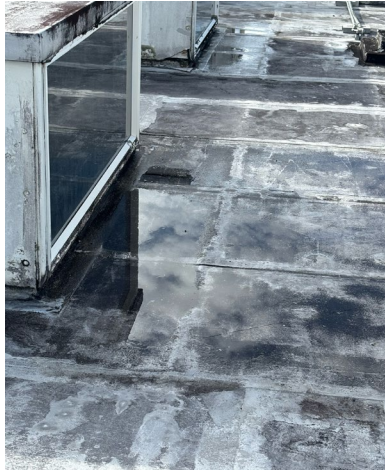
Asset condition photos

Weathertightness and air quality (mould) testing is urgently needed for the 3 barrack blocks listed .
The team at Whenuapai have started looking into 'live in' numbers to come up with alternate accommodation options, should this be needed post testing.

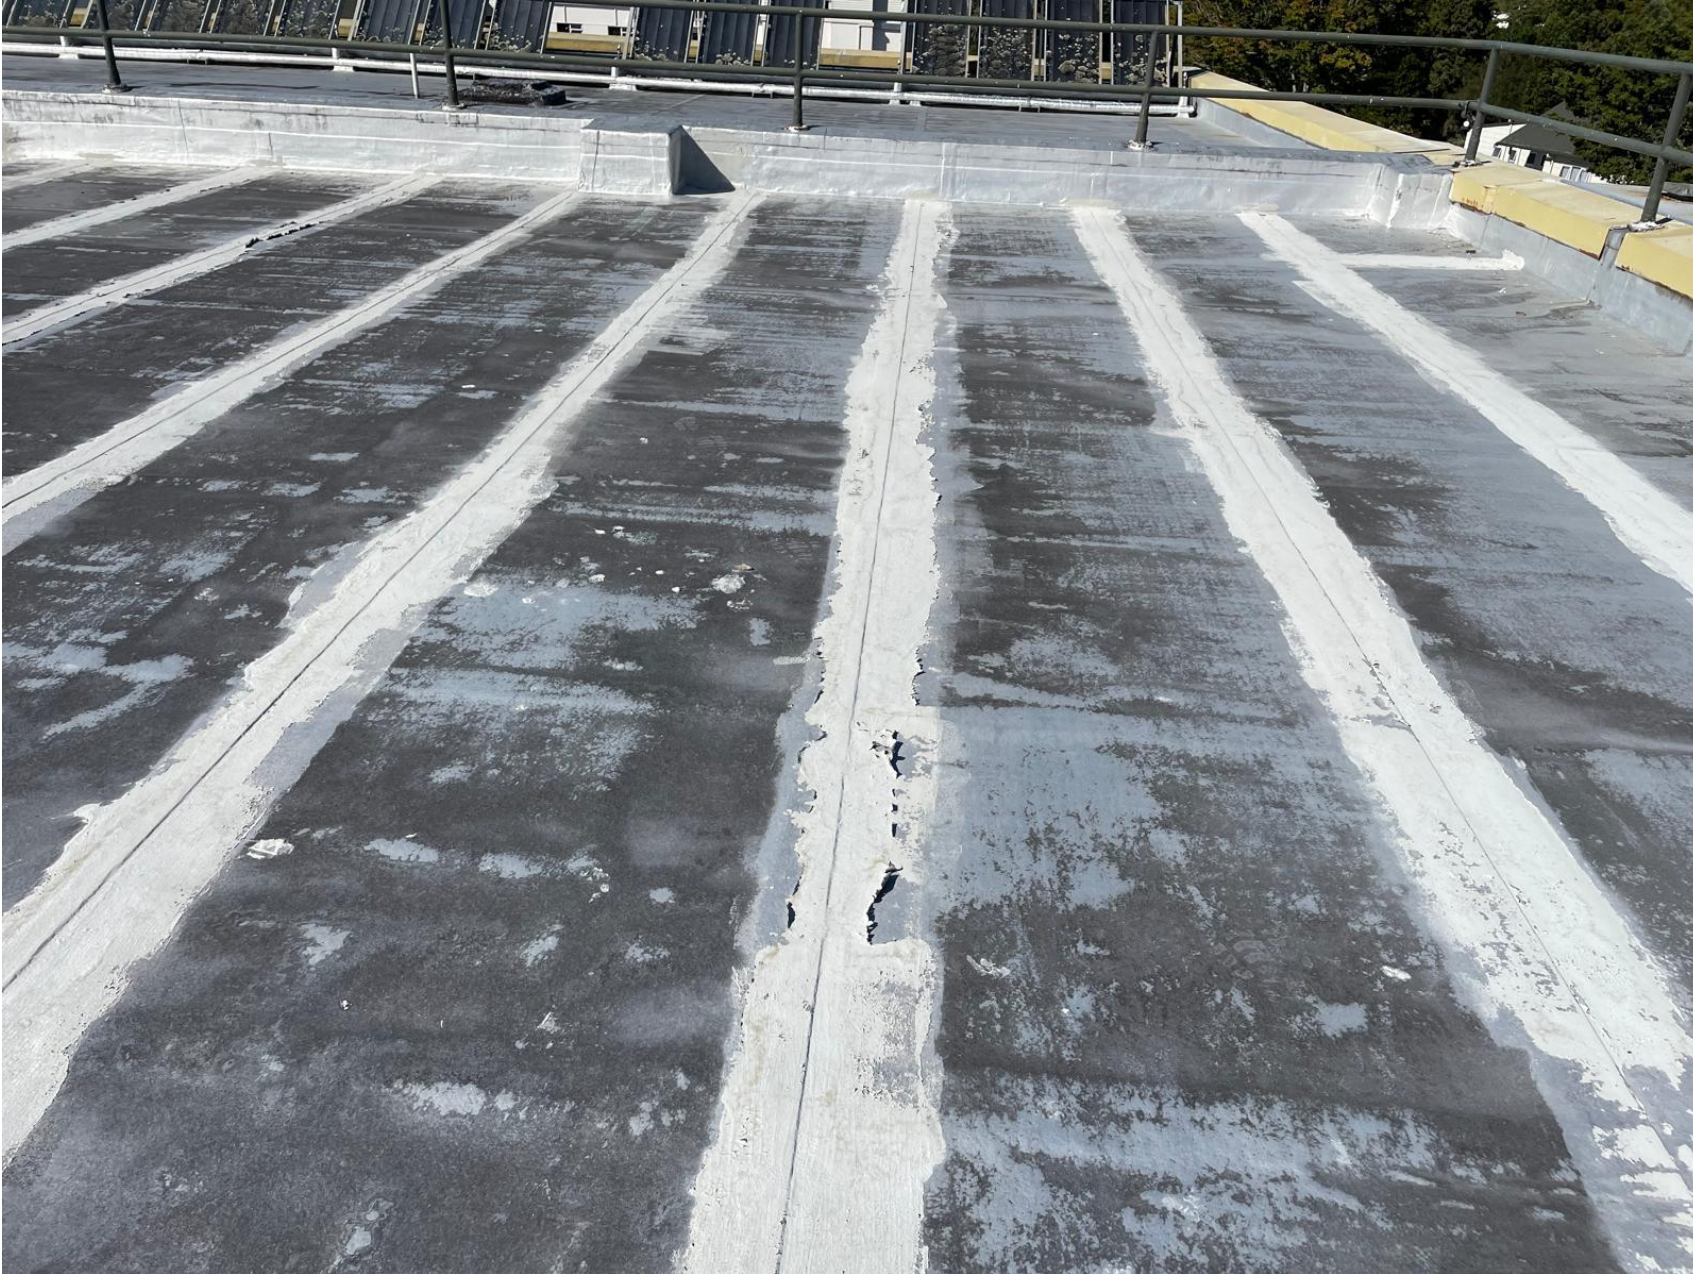
Bristol Block – Membrane is failing, this is the area over the combined mess , as you can see the patch repair is failing and needs attention. However, the entire membrane needs to be replaced, this prolonged failure has lead to water ingress issues where no one source of the leak can be found to be contributing to the issue.

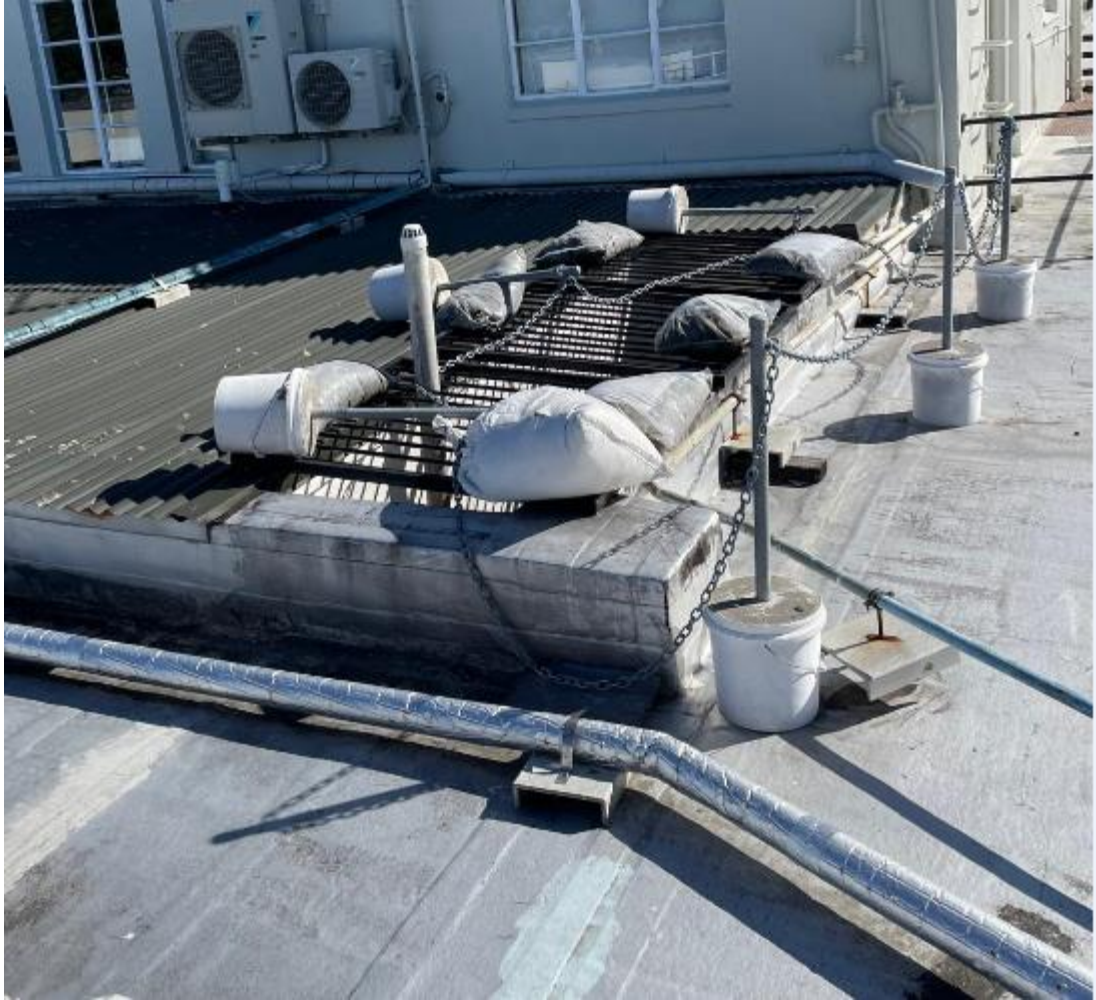
This is one of multiple voids on the roof of Bristol Block that is temporarily covered. Not exactly a permanent solution.

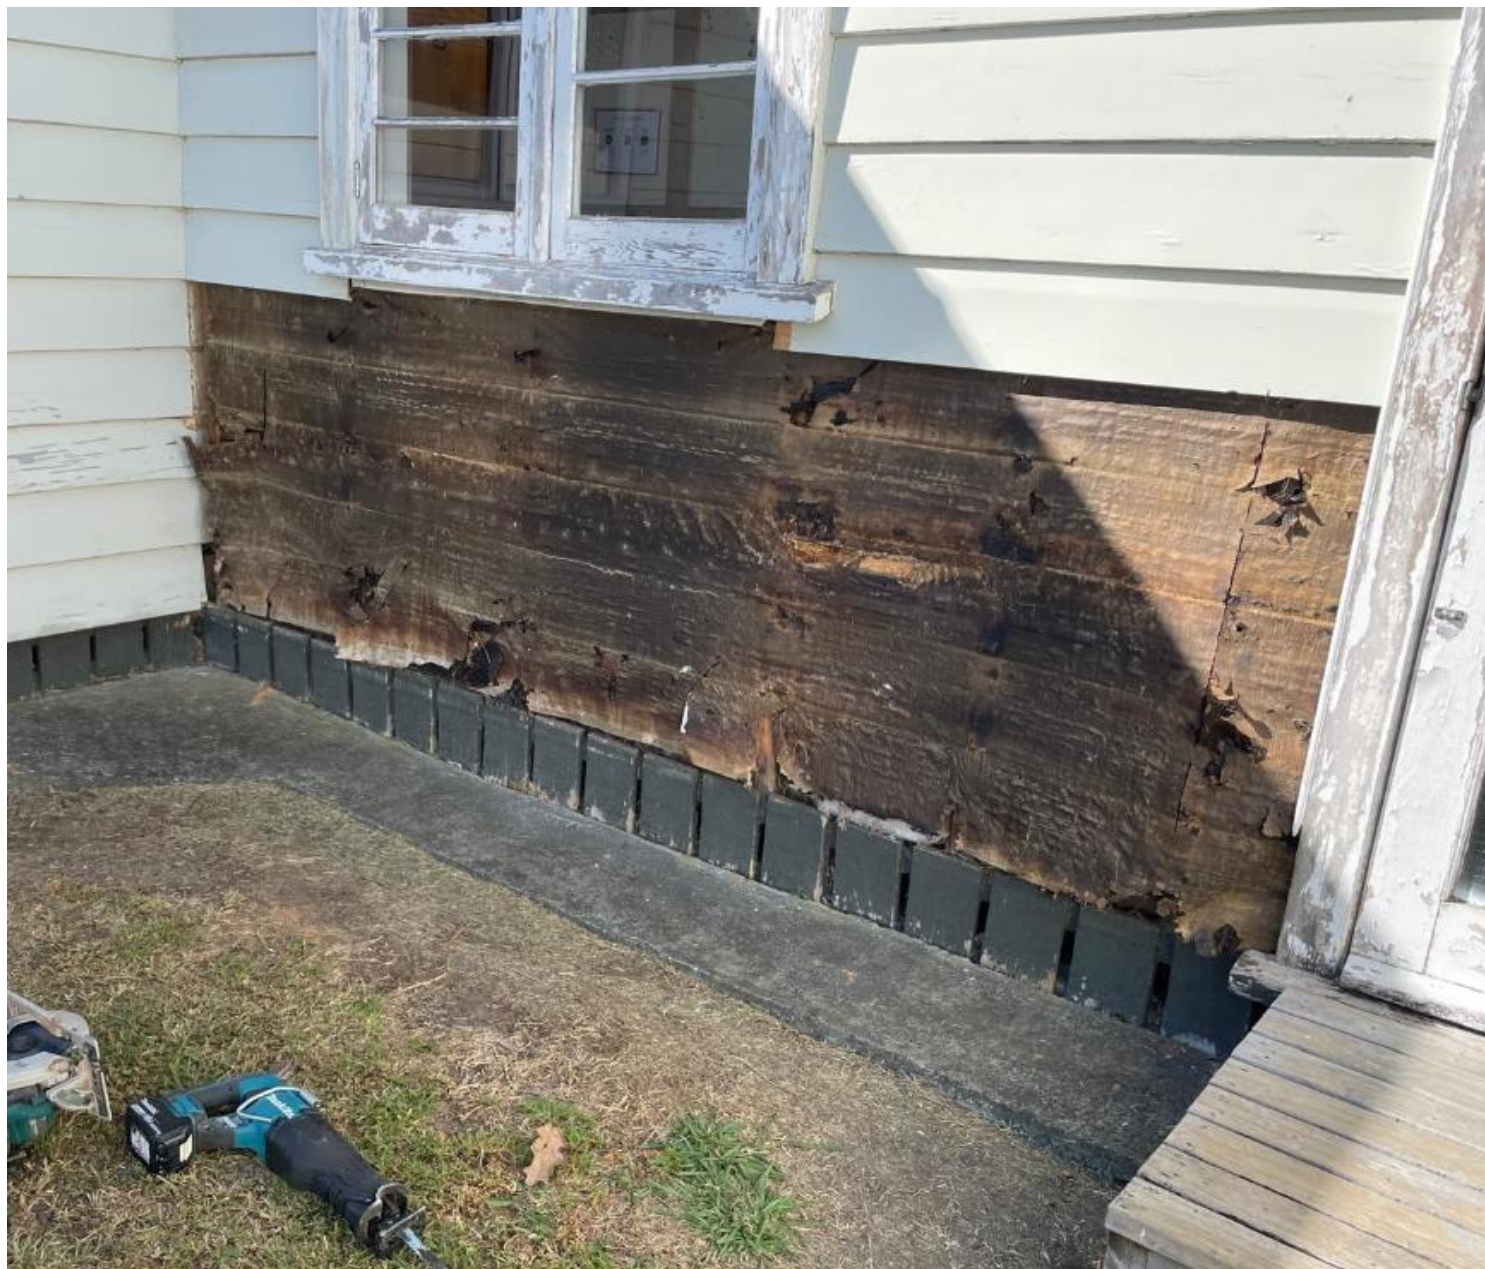
We are currently undertaking some repairs to the cladding of Dakota Block. The future accommodation is designed and 'shovel ready' to replace this building but not yet prioritized to proceed. This is the state of the damp proof membrane, Hume Block is expected to be no different. However, we have no design for that barrack block replacement yet.

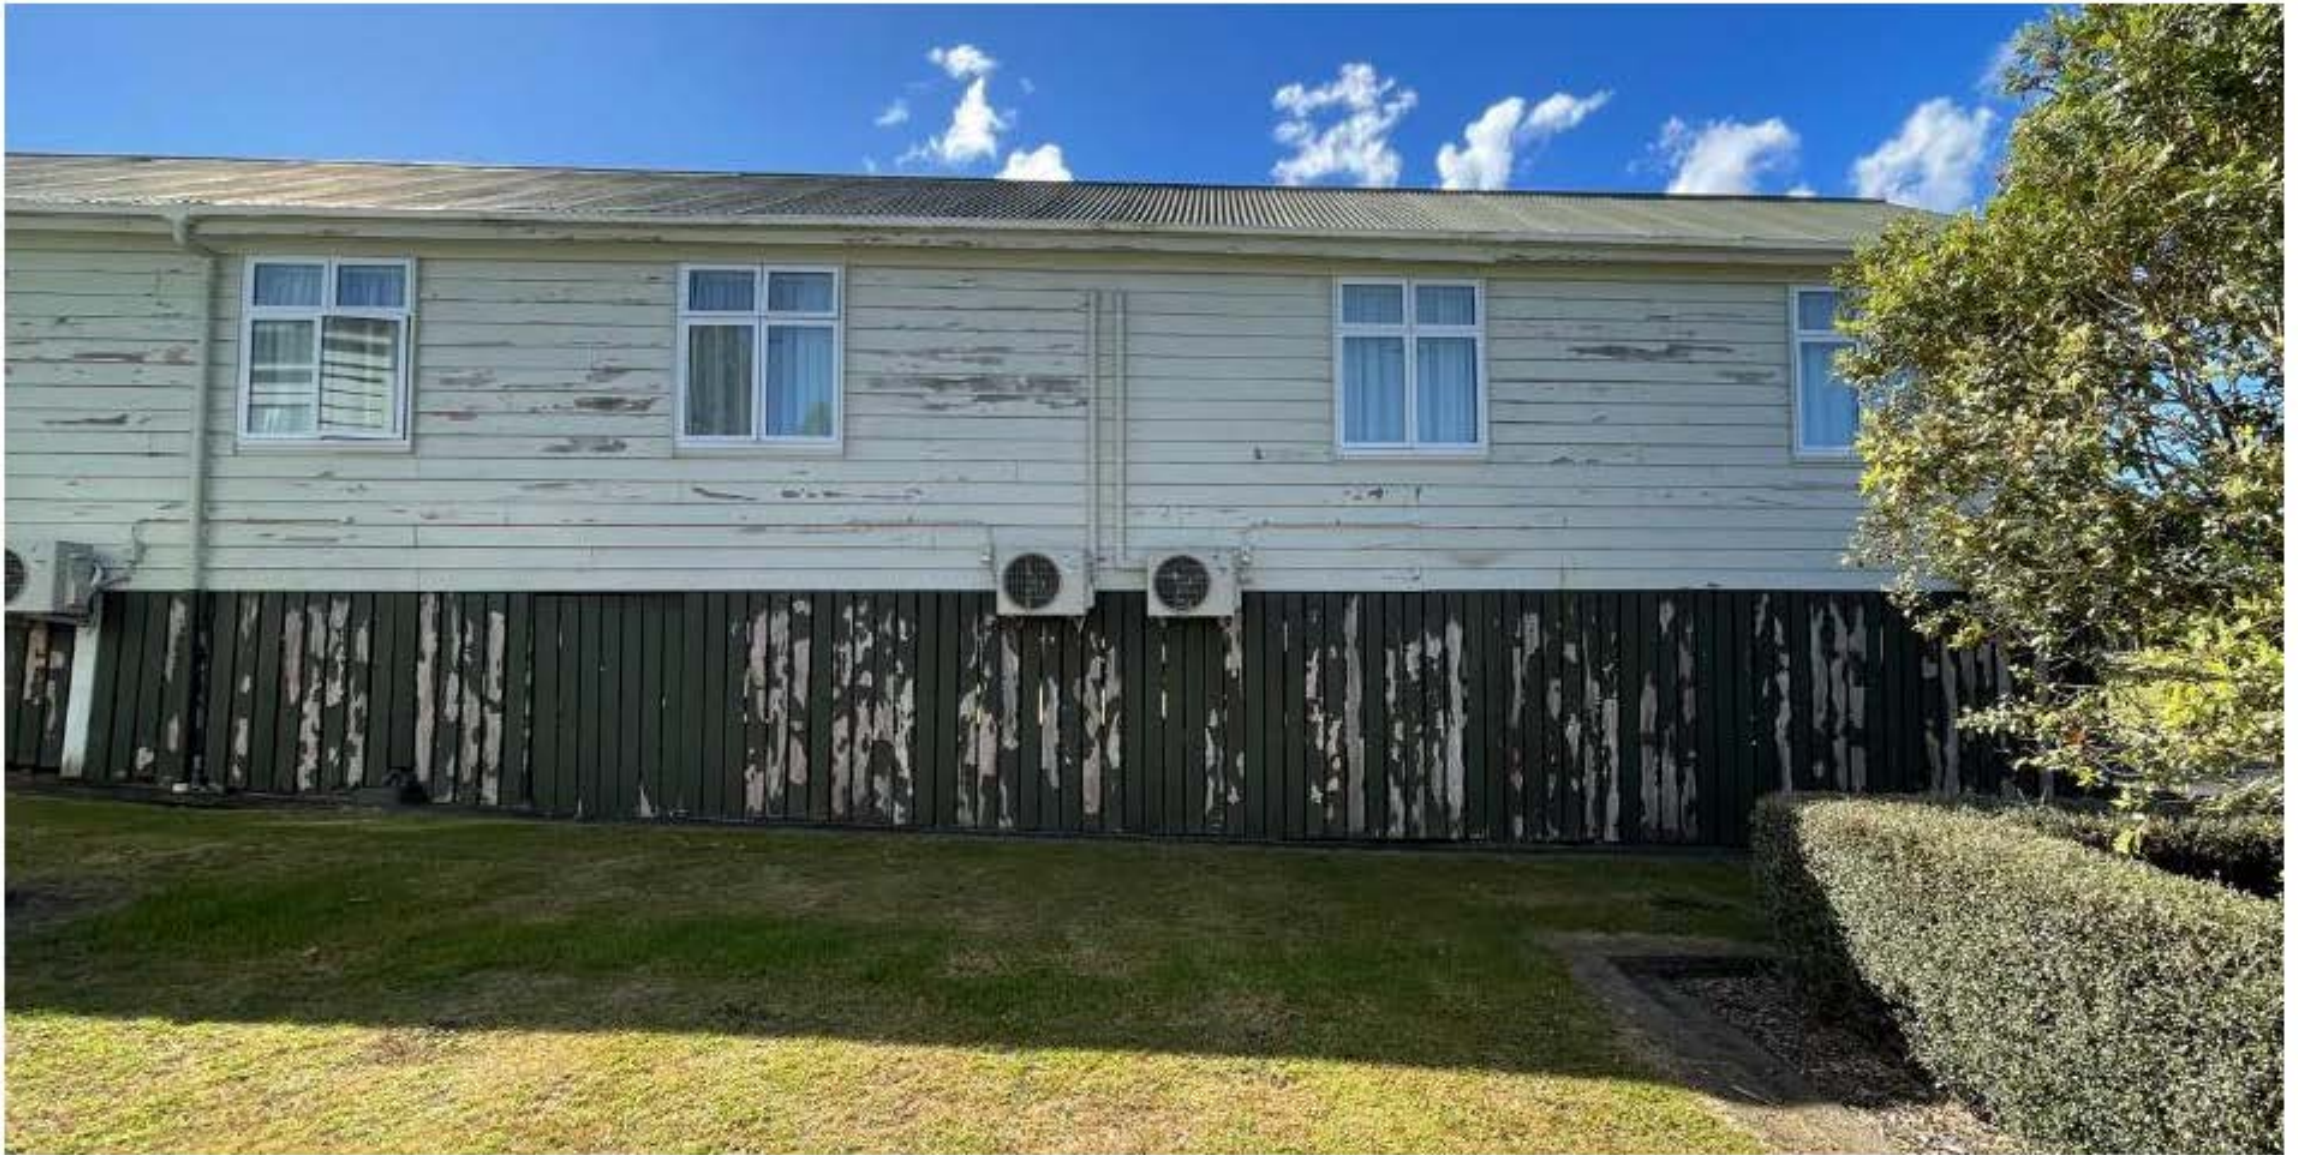
Deteriorating Cladding of Hume Block
