COURT OF INQUIRY
(Army 5202/2/301)

X1028259 PRIVATE MICHAEL VICTOR ROSS, RNZIR

DROWNED IN LAKE MOAWHANGO WHILE ON EXERCISE

WAIOURU MILITARY TRAINING AREA

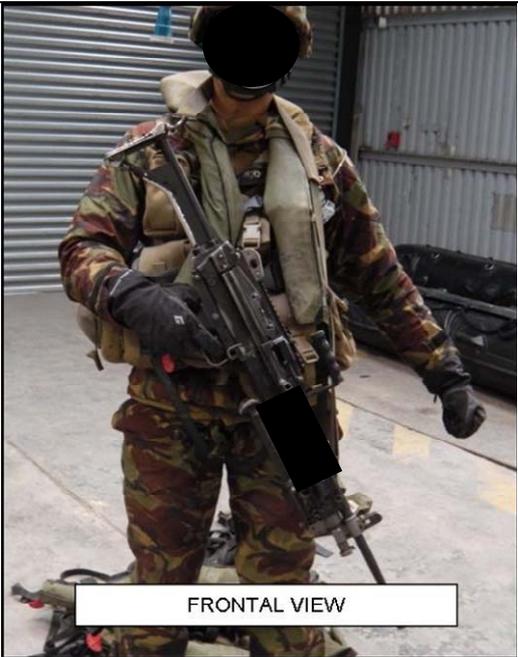
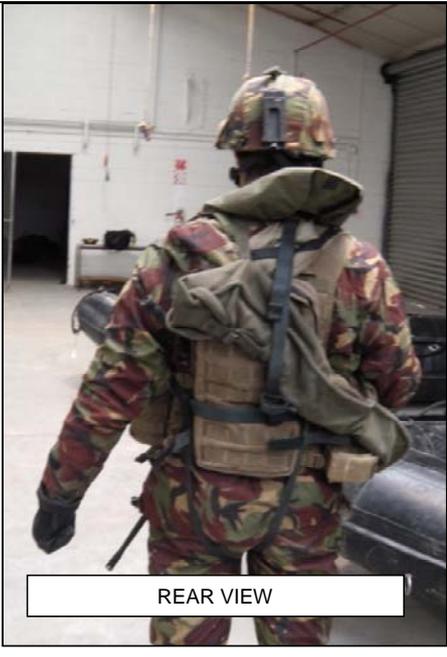
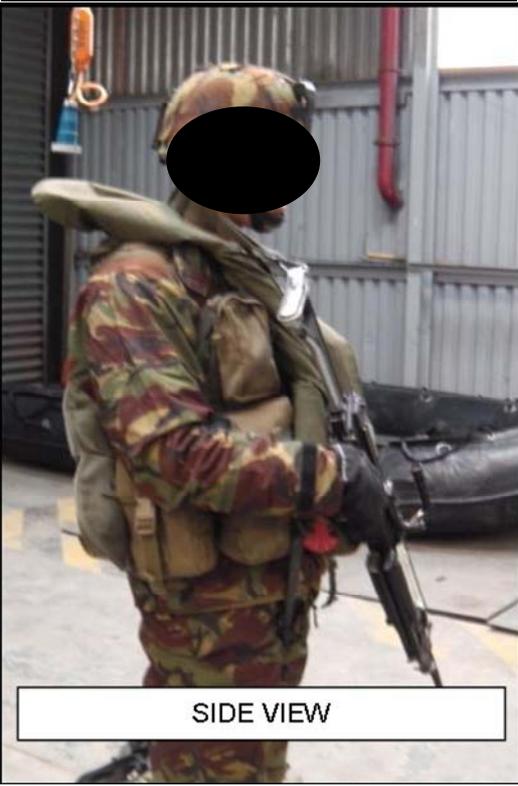
Table 5: Indicative Equipment being worn by Private Ross at time of Incident

<p style="text-align: center;">SIDE VIEW</p>	<p>Note:</p> <ul style="list-style-type: none"> • Life jacket is worn over webbing • Light Support Weapon is slung around neck over the top of the life jacket • B (spare) barrel is worn on back and underneath life jacket • Red toggle is exposed on right hand side • Wet weather jacket • Helmet has night vision goggle mount affixed • Note: Private Ross was not wearing gloves.

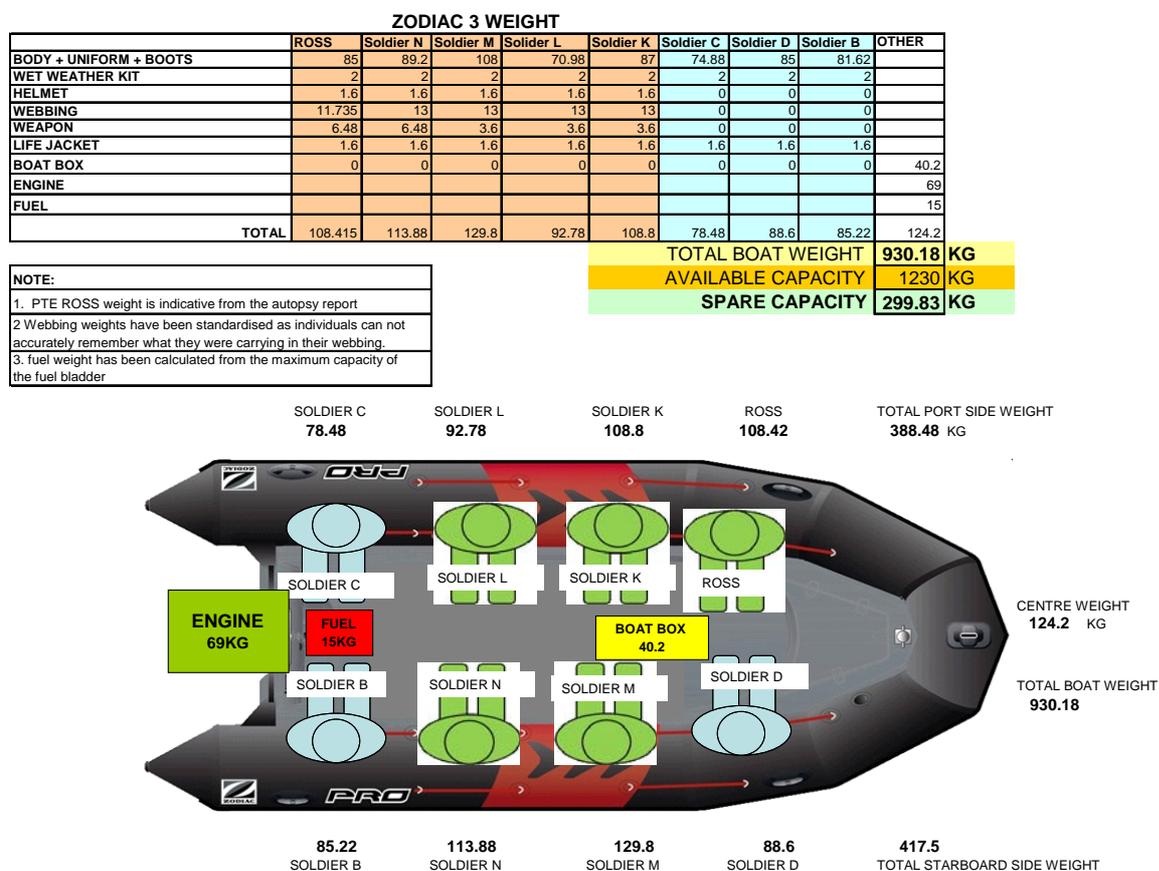
78. The School of Military Engineering Corps Training Watermanship publication provides for the Zodiac to carry two crew and eight soldiers in patrol order, or alternatively four soldiers in field service marching order; or two crew and a cargo of up to 1000kg.¹²²

79. The Court finds that on 25 September 2012, Zodiac 3 was carrying eight personnel, one of whom was Private Ross. Five of these soldiers were dressed in patrol order. By order of the Court, the soldiers onboard the Zodiac from which Private Ross fell overboard were weighed, wearing the exact same equipment they had on the day of the incident. The combined total boat weight, including the boat box, engine and fuel was 930.18 kilograms as shown in Figure 12.¹²³ This was within the capacity of the Zodiac as listed in the manufacturer's specification, the NZ P96 and the School of Military Engineering publication.
