OIA-2026-5806

1. Toxic Gas Incidents between 23-28 November 2022 in HMNZS Te Mana
2. Two RNZAF UNIMOG's rolling over in August 2024
3. Injury during live firing practice, Ardmore MTA

**REPORT OF THE COURT OF INQUIRY  
REGARDING  
TOXIC GAS INCIDENTS BETWEEN 23-28 NOVEMBER 2022 IN HMNZS TE MANA**

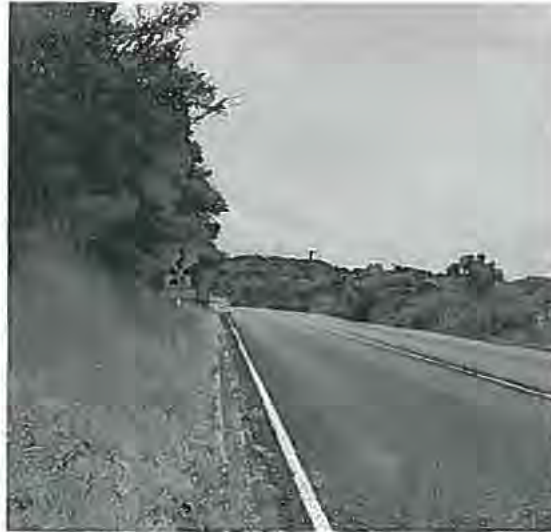
Photograph 4. Extract from Exhibit 15 F.

44. The NZTA signs warn motorists of a winding section of road 2km in length where due to road alignment factors this section of road has an operating speed of 45kph, considerably below that of the remainder of the road at 80kph,<sup>40</sup> (Photograph 4). The NZTA website qualifies the application of supplementary speeds, stating that the recommended speed for hazard areas is based on a light vehicle and that speeds may be too fast for a heavy vehicle.<sup>41</sup>

**Finding 6:** Acknowledging that the road was wet, the Court finds no evidence of any unknown or unavoidable factors with the road or environment that may have contributed to the rollover. The Court finds the inherent hazard of this section of road to be prominently and permanently identified by NZTA warning signs that advise motorists to reduce speed.
